**Device**            **XC886CM-8FF**  
**Marking/Step**   **EES AA**  
**Package**         **PG-TQFP-48**

This Errata Sheet describes the deviations from the current user documentation. The module oriented classification and numbering system uses an ascending sequence over several derivatives, including already solved deviations. So gaps inside this enumeration can occur.

# 1 History List/Change Summary

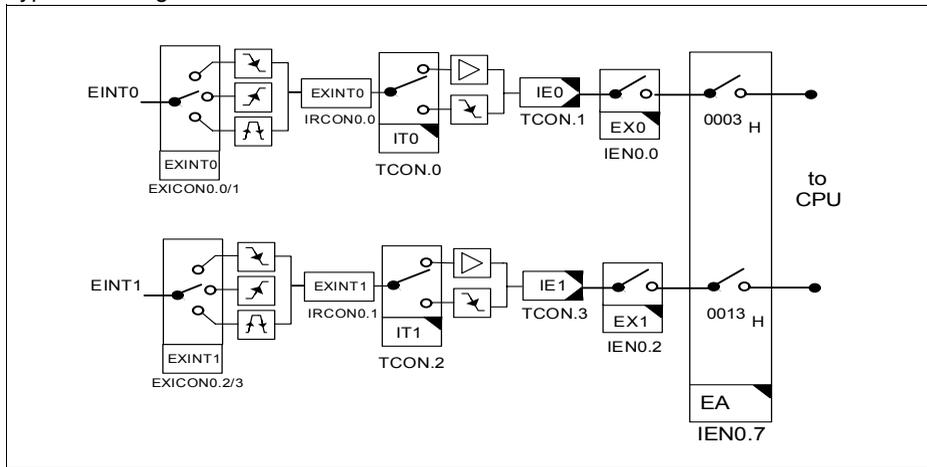
**INT\_XC8.H003 Interrupt Flags of External Interrupt 0 and 1**

External interrupt 0 and 1 may individually be selected via respective bits (EXINTx) in EXICON0 register, to request interrupt on falling edge, rising edge, both edges or to bypass the edge detection.

Edge detection is done in the system unit. If enabled, an active event will set the EXINTx flag and correspondingly set the IEx flag in TCON. It should be noted that after any external interrupt x event, flag EXINTx must be cleared. In case of falling edge as active event, this allows any future active event to be able to set the flag IEx as interrupt request. In case of low level as active event, this prevents unintended recurring triggering of interrupt request.

In case of bypass edge detection, the input is connected directly to the core (bypass the system unit). The flag IEx in TCON will be set on the selected falling edge or low level (at least 2 clock cycles) event. In case of falling edge selected as active event by TCON.ITx, the flag EXINTx is set in addition to the flag IEx.
