**Device**                **XC888CM-8FF**  
**Marking/Step**      **ES AB**  
**Package**            **PG-TQFP-64**

This Errata Sheet describes the deviations from the current user documentation. The module oriented classification and numbering system uses an ascending sequence over several derivatives, including already solved deviations. So gaps inside this enumeration can occur.

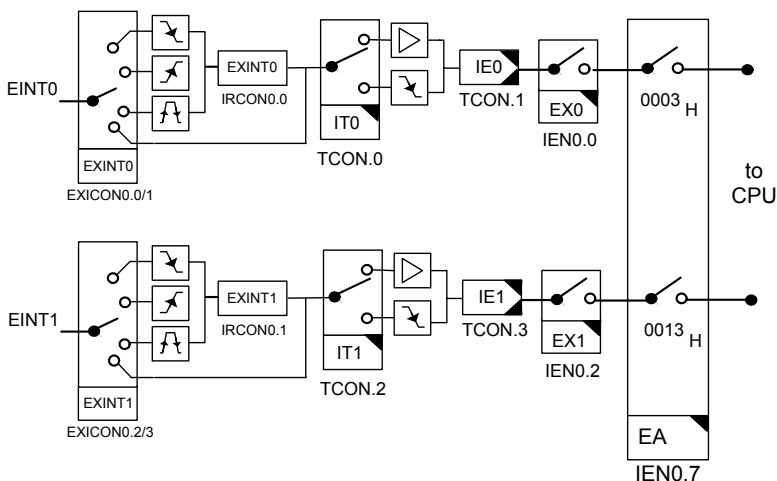
**Figure 8**

**INT\_XC8.H003 Interrupt Flags of External Interrupt 0 and 1**

External interrupt 0 and 1 may individually be selected via respective bits (EXINTx) in EXICON0 register, to request interrupt on falling edge, rising edge, both edges or to bypass the edge detection.

Edge detection is done in the system unit. If enabled, an active event will set the `EXINTx` flag and correspondingly set the `IEx` flag in `TCON`. It should be noted that after any external interrupt `x` event, flag `EXINTx` must be cleared. In case of falling edge as active event, this allows any future active event to be able to set the flag `IEx` as interrupt request. In case of low level as active event, this prevents unintended recurring triggering of interrupt request.

Besides the above notes, the following should be noted on the behavior regarding setting and clearing of the external interrupt `x` (`x = 0` or `1`) flags, applicable to both edge and bypass edge detection modes:
