Device	XMC4400
Marking/Step	EES-AA, ES-AA
Package	PG-LQFP-64/100

Document ID is **02512AERRA**.

This “Errata Sheet” describes product deviations with respect to the user documentation listed below.

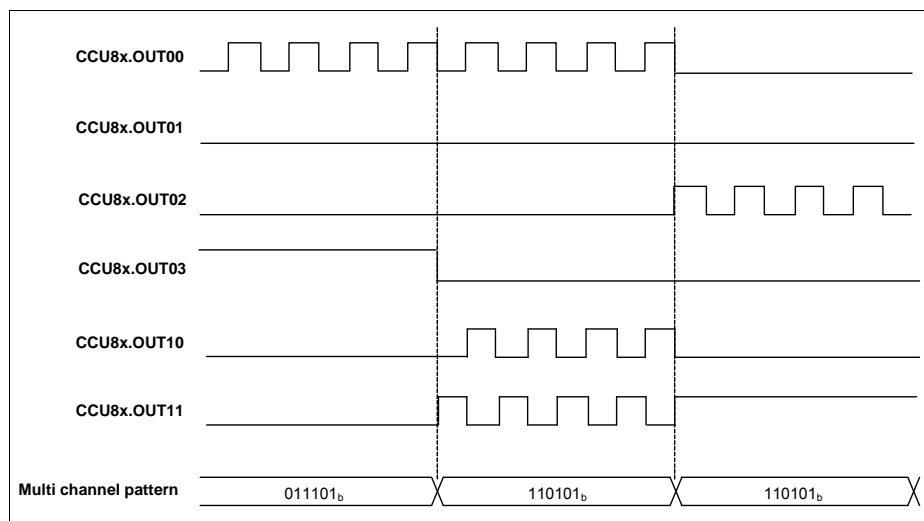
Figure 5 Multi Channel Mode applied to several CCU8 outputs

A glitch is present at the PWM outputs whenever the dead time of the specific compare channel is enabled - CC8yDTC.DTE1 and/or CC8yDTC.DTE2 set to 1_B (each compare channel has a separate dead time function) - and the specific multi channel pattern for the channel is 01_B or 10_B .

This glitch is not present if the specific timer slice is configure in symmetric edge aligned mode - CC8yTC.TCM = 0_B and CC8yCHC.ASE = 0_B .

This glitch only affects the PWM output that is linked to the inverting ST path of each compare channel (non inverting outputs are not affected).

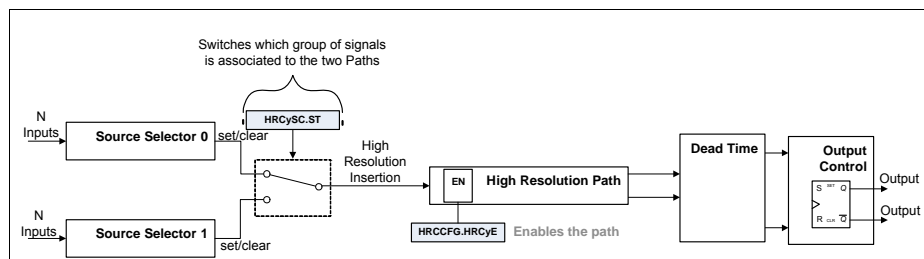
Figure 10 HRC with only one path enabled and two Source Selectors

This scenario where only one path is enabled but both Source Selectors are being used, and by being used is understood that signals are being actively decoded from the Source Selectors (input signals for the Source Selectors are being updated) is depicted on **Figure 10** - in this example the High Resolution Path is the one being used.

In the above scenario, every time that the HRCyST.ST bitfield is 1_B , the Source Selector 1 is the one that has control over the PWM signal. Whenever the HRCyST.ST bitfield is 0_B is the Source Selector 0 that has control over the PWM signal.

If the described condition occurs, then the signal generated by Source Selector 1 is lost and the PWM signal is not handled properly - **Figure 11**.

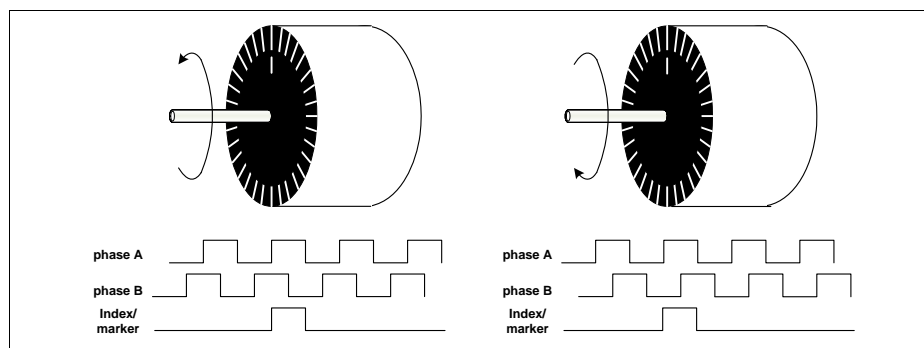
Figure 18 Rotary Encoder outputs - Phase A, Phase B and Index

When the index signal is smaller than 1/2 of the tick period, the POSIF module is not able to decode this signal properly, Figure 2 - notice that the reference edge of the index generation in this figure is the falling of Phase B, nevertheless this is an example and depending on the encoder type, this edge may be one of the other three.
