Device	XMC4500
Marking/Step	EES-AA, ES-AA
Package	PG-LQFP-100/144, PG-LFBGA-144

Document ID is **02462AERRA**.

This “Errata Sheet” describes product deviations with respect to the user documentation listed below.

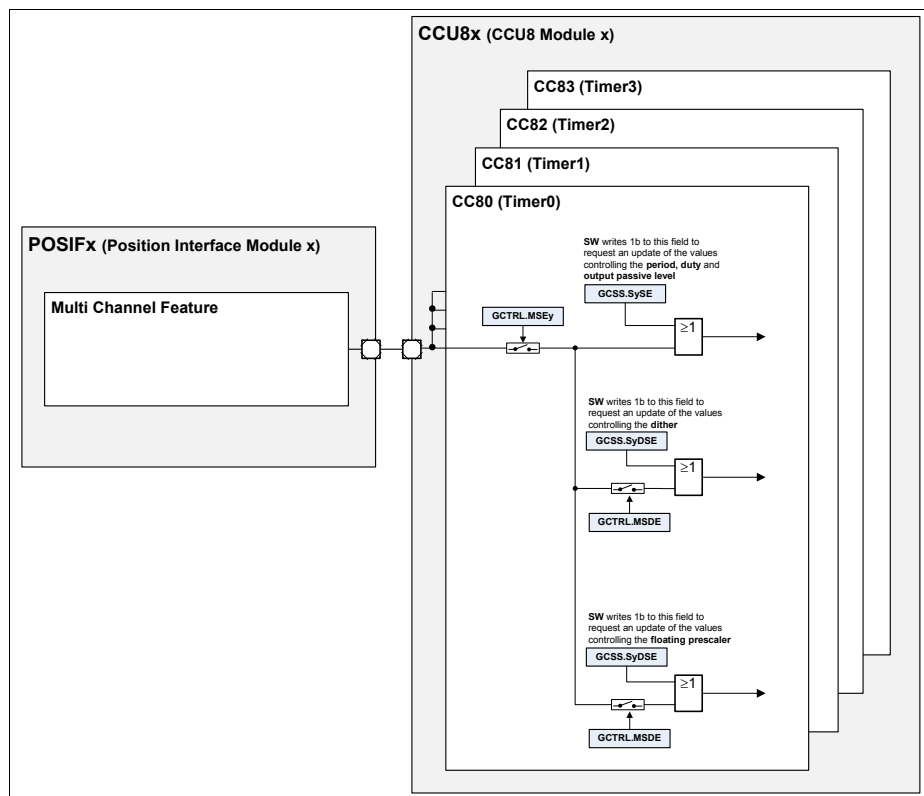
Figure 3 Value update trigger connection between CCU8x and POSIFx

The signal between the POSIFx and CCU8x module is used to handshake a concurrent update between several registers, contained in the two modules. The output signal of the POSIFx is named as POSIFx.OUT6 while the input signal on the CCU8x side is named as CCU8x.MCSS.

On Figure 2, we see an example how this trigger is used to update at the same time the duty cycle value of a timer inside the CCU8x and the multi channel pattern inside the POSIFx (the multi channel pattern can affect the CCU8x timer outputs therefore a synchronous update of all the values solves possible output glitches on the generated PWM signals).

On Figure 2, the SW has updated the next values for the duty cycle on a CCU8x Timer (it can be also for the period, output passive level and clock prescaler). After that it updates also the next value of the multi channel pattern inside the POSIFx module. After that, the POSIF reaches an internal state (dictated by specific conditions) where an update of the values is needed. It generates a trigger signal to the CCU8x Timer to signalize that an update of the duty cycle

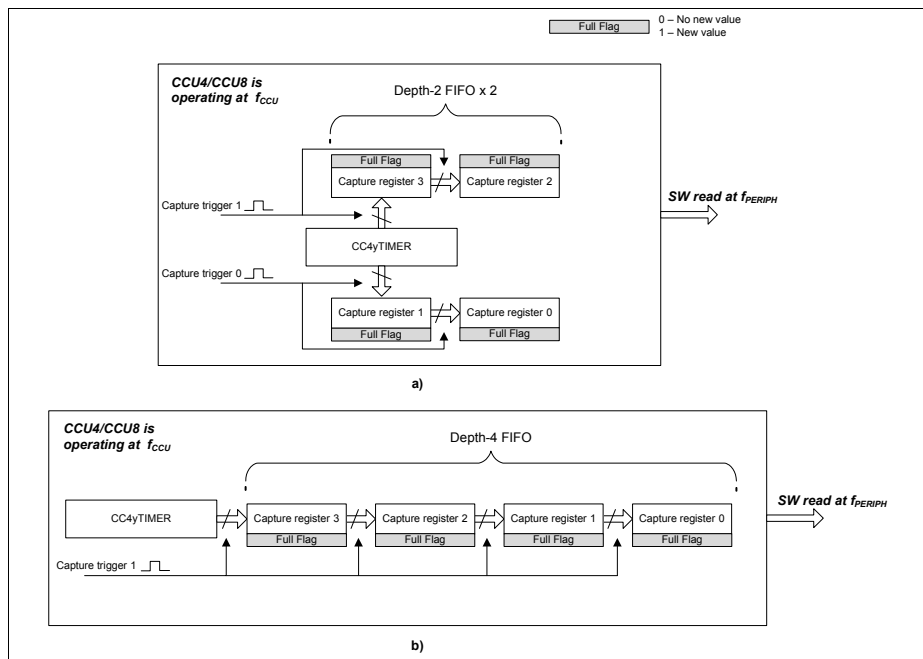
Figure 7 Capture Modes Structure - a) Depth-2 x2 Capture; b) Depth-4 Capture

Each CCU4/CCU8 Timer Slice contains a Full Flag field in every capture register. The structure of the different capture modes for each Timer Slice can be seen in [Figure 7](#).

When a capture event collides with a read back on the data bus, the proper data is read by the software, but this data is shifted to the immediately capture register and the associated full flag is set, [Figure 8](#) - for simplification purposes a 2 depth capture scheme is shown.

Referring to [Figure 8](#), it can be understood that the proper data is sent to the software when it reads back the capture register 1, nevertheless this same data is shifted to the next capture register (capture register 0) and the full flag of this register is set.

After this if the software reads back capture register 0, a value is going to be returned with a full flag set (indicating that this is a new value - that has not yet been read, which is not true).

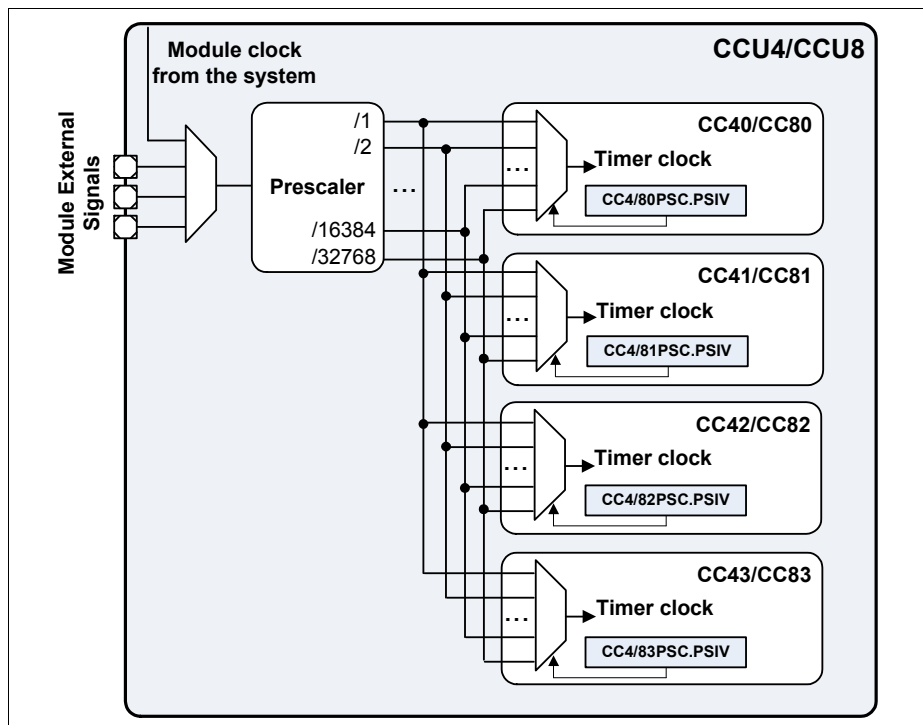
Figure 10 Clock Selection Diagram for CCU4/CCU8

This is only applicable if the Module Clock provided by the system (the normal default configuration and use case scenario) is not being used. In the case that the normal clock configured and programmed at system level is being used, there is not any type of constraints.

One should not also confuse the usage of an external signal as clock for the module with the usage of an external signal for counting. These two features are completely unrelated and there are not any dependencies between both.

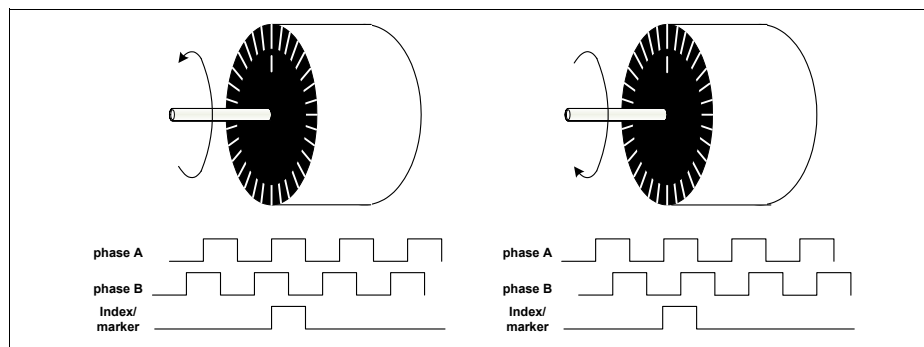
Figure 16 Rotary Encoder outputs - Phase A, Phase B and Index

POSIF AI.001 Input Index signal from Rotary Encoder is not decoded when the length is 1/4 of the tick period

Each POSIF module can be used as an input interface for a Rotary Encoder. It is possible to configure the POSIF module to decode 3 different signals: Phase A, Phase B (these two signals are 90° out of phase) and Index. The index signal is normally understood as the marker for the zero position of the motor Figure 1.

When the index signal is smaller than 1/2 of the tick period, the POSIF module is not able to decode this signal properly, Figure 2 - notice that the reference edge of the index generation in this figure is the falling of Phase B, nevertheless this is an example and depending on the encoder type, this edge may be one of the other three.

To make usage of the Index signal, when the length of this signal is less than 1/2 of the tick period, one should connect it directly to the specific counter/timer. This connection should be done at port level of the device (e.g. connecting the device port to the specific Timer/Counter(s)), Figure 3.
