TLE986xQX Family - BE-Step
TLE987xQX Family - BE-Step

Overview

This document lists the errata of the TLE986xQX family and the TLE987xQX family, for related products please refere to **Table 2**.

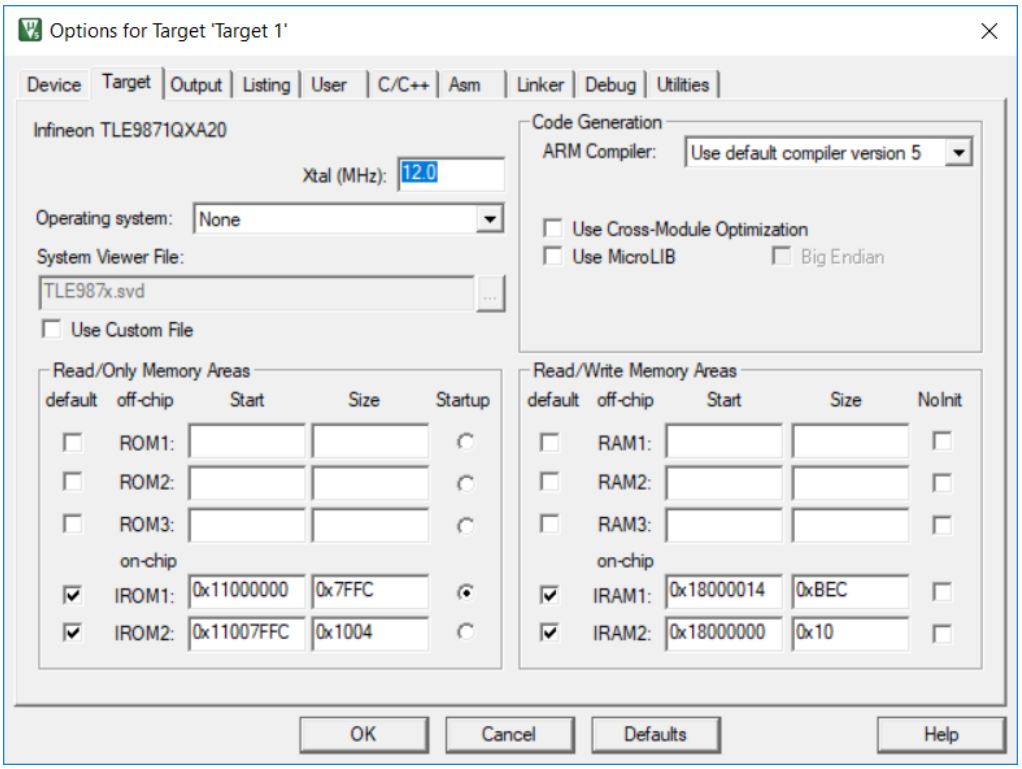
Figure 1 Example IRAM settings for the TLE9871QXA20

The function USER_NVM_ECC_CHECK uses for its operation 32 bytes on the user stack plus 1 byte in user RAM at address 0x18000011, this is not clearly specified in the BootROM User Manual.

Adjust the project IRAM settings to exclude this address from the RAM area usable by the linker. In order to maintain memory alignment a hole of four bytes, from 0x18000010 to 0x18000013 is recommended. **Figure 1** displays an example for the TLE9871QXA20. **Table 3** lists the recommended IRAM settings for each device.

Device	IRAM1 Start	IRAM1 Size	IRAM2 Start	IRAM2 Size
TLE9861QXA20	0x18000014	0xBEC	0x18000000	0x10
TLE9867QXA20	0x18000014	0x17EC	0x18000000	0x10
TLE9867QXA40	0x18000014	0x17EC	0x18000000	0x10
TLE9869QXA20	0x18000014	0x17EC	0x18000000	0x10
TLE9871QXA20	0x18000014	0xBEC	0x18000000	0x10
TLE9877QXA20	0x18000014	0x17EC	0x18000000	0x10
TLE9877QXA40	0x18000014	0x17EC	0x18000000	0x10
TLE9879QXA20	0x18000014	0x17EC	0x18000000	0x10
TLE9879QXA40	0x18000014	0x17EC	0x18000000	0x10

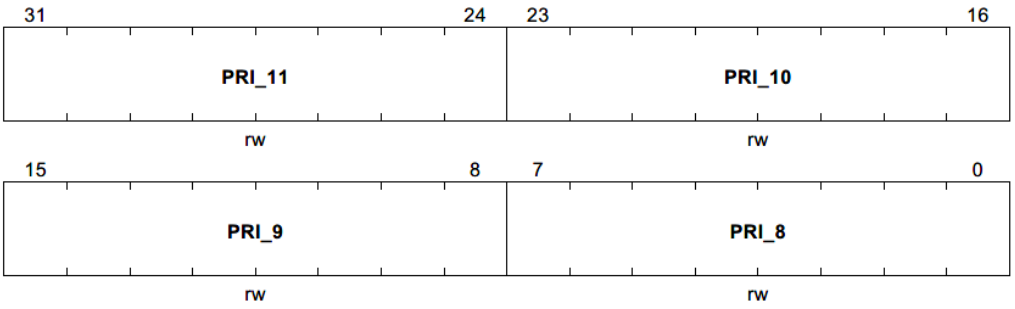
Figure 4 Register view of specified SHPR2 register

The address of the register SHPR2 is specified wrongly.

Fix with next user documentation update.

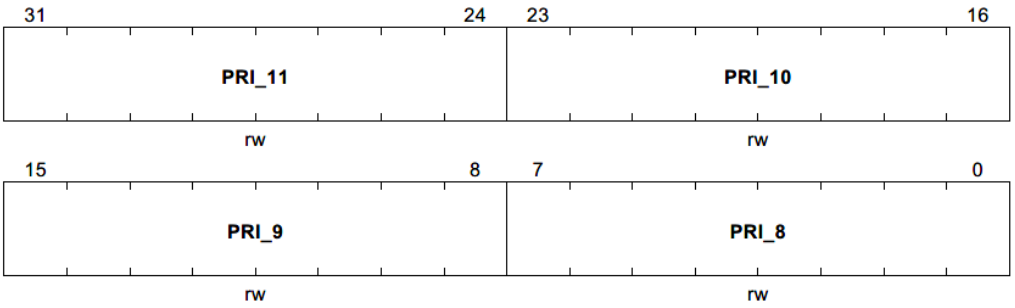
Figure 5 Register view of implemented SHPR2 register

The imlemented address for the register SHPR2 is 0xE000ED1C.
