Devices	C164CI-8R, C164SI-8R, C164CL-8R, C164SL-8R, C164xy-L
Marking/Step	Step ES-AB, AB
Package	P-MQFP-80-1 (C-MQFP-80: EES-AB only)

This Errata Sheet describes the deviations from the current user documentation.

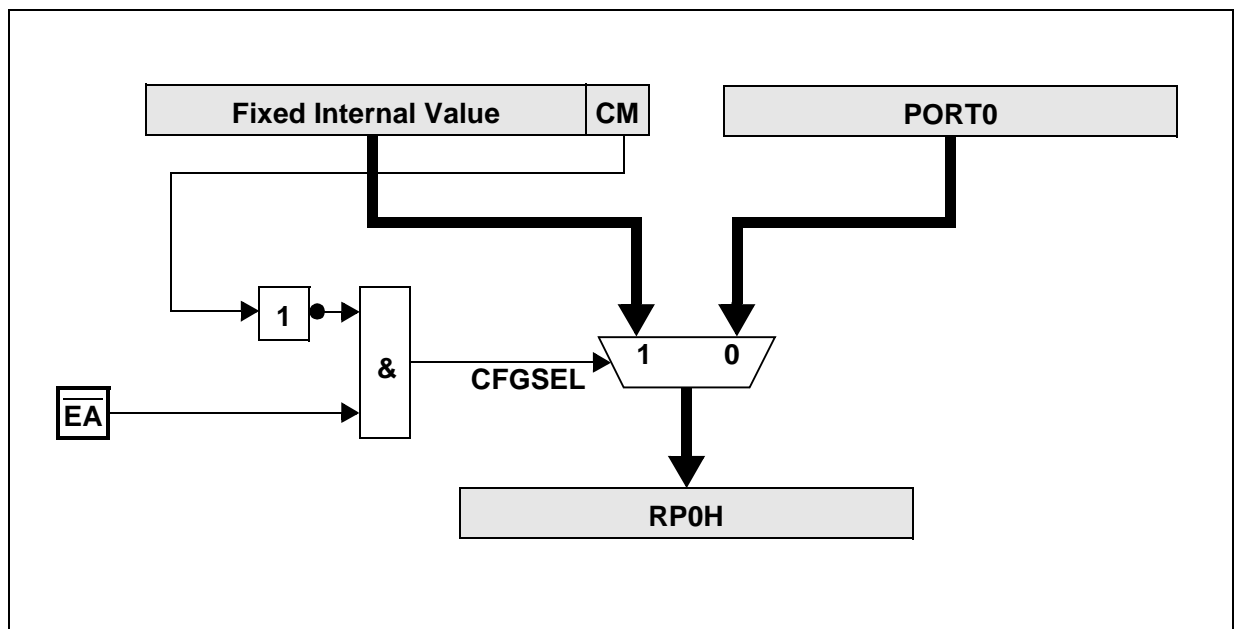
Figure 1 Reset Configuration Source Selection

For a single-chip mode reset (indicated by $\overline{EA} = 1$) the configuration via PORT0 can be replaced by a fixed configuration value. This fixed configuration value is hardwired and is selectable for each ROM mask. In this case PORT0 needs no external circuitry (pullups/pulldowns) and also the internal configuration pullups are not activated.

The logic described in the figure above controls the reset configuration source (see signal CFGSEL) in the following way:

- Compatible mode, configuration via PORT0
- Internal mode, configuration via fixed value

In contrast to the user's manual in the C164CI-8R the register RSTCON is not available. After single-chip mode reset the register RP0H is not set to the described default value but shows the configuration defined in the ROM mask (Configuration Byte) as follows.

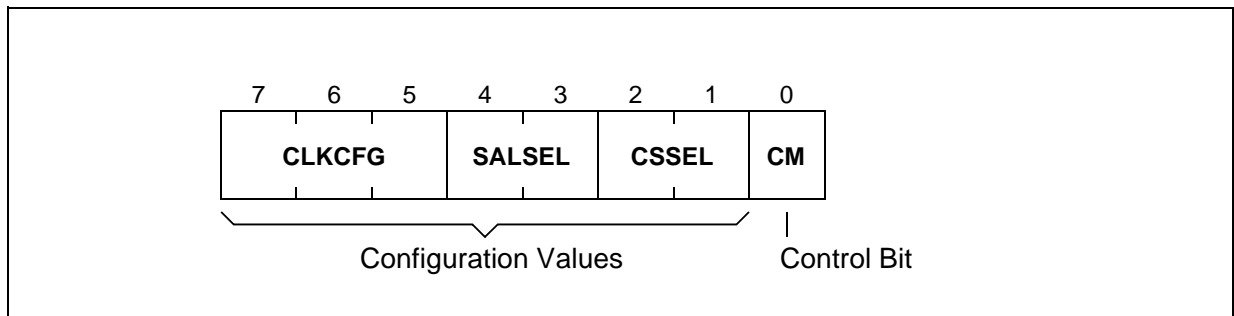
Figure 2 Internal Reset Configuration Byte

The fixed internal value and the compatibility mode control bit CM for the Single-Chip reset are specified by a byte value described below. This byte value shall be stored at location 00'003EH within the user ROM code.

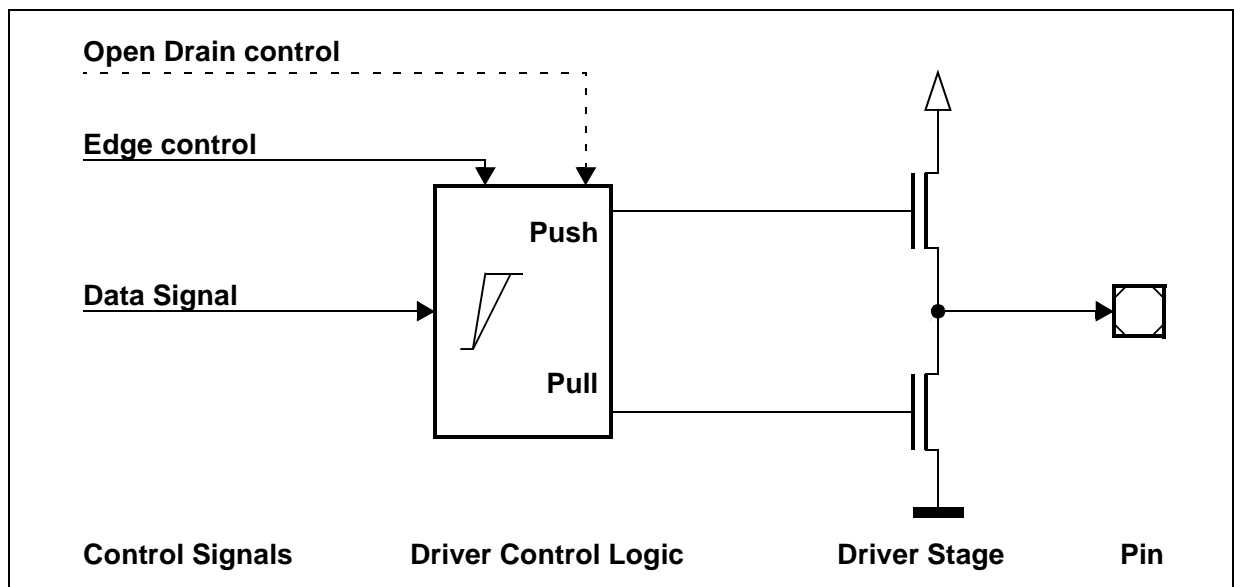
Figure 1 Structure of Output Driver with Edge Control

Edge Characteristic

This defines the rise/fall time for the respective output, i.e. the output transition time. Slow edges reduce the peak currents that are drawn when changing the voltage level of an external capacitive load. For a bus interface, however, fast edges may still be required. Edge characteristic effects the pre-driver which controls the final output driver stage.

The **Port Driver Control Register** PDCR provides the corresponding control bits. A separate control bit is provided for bus pins as well as for non-bus pins.

Bit	Function
BIPEC	<p>Bus Interface Pins Edge Characteristic (Defines the outp. rise/fall time t_{RF})</p> <p>0: Fast edge mode, rise/fall times depend on the driver's dimensioning.</p> <p>1: Reduced edge mode.</p> <p>BIPEC controls: PORT0, PORT1, Port 4, \overline{RD}, \overline{WR}, ALE, CLKOUT, $\overline{BHE/WRH}$, \overline{RSTOUT}, \overline{RSTIN} (bidirectional reset mode only).</p>
NBPEC	<p>Non-Bus Pins Edge Characteristic (Defines the output rise/fall time t_{RF})</p> <p>0: Fast edge mode, rise/fall times depend on the driver's dimensioning.</p> <p>1: Reduced edge mode.</p> <p>NBPEC controls: Port 3, Port 8</p>

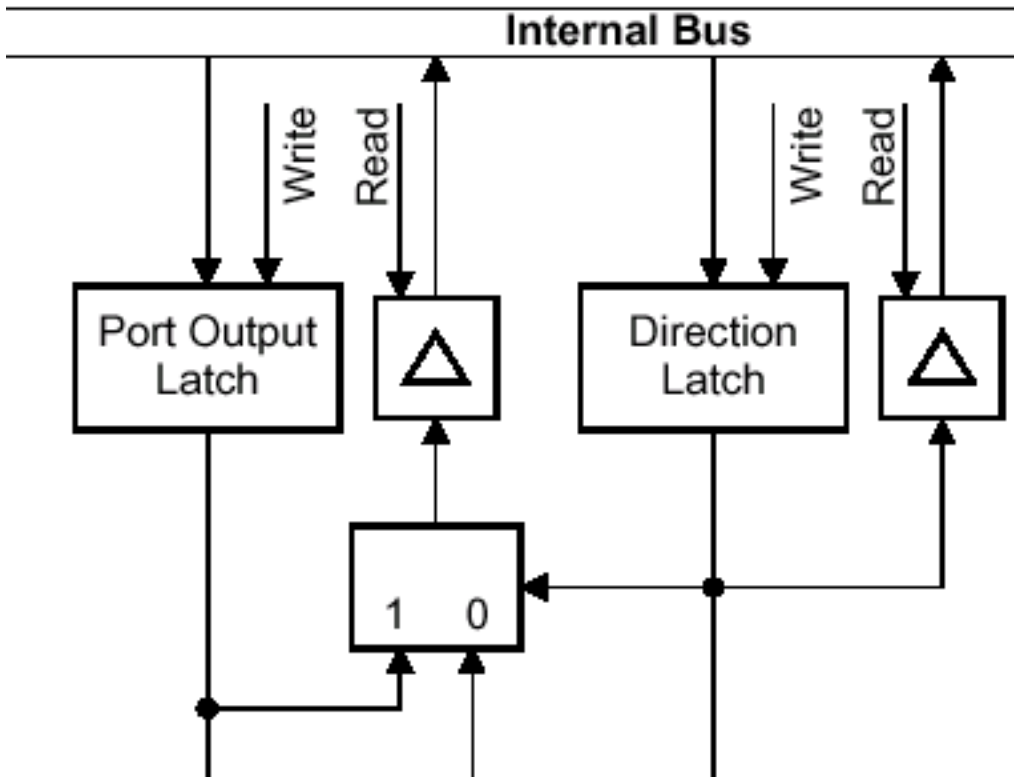
Correct Port Output Latch read multiplexer description:
