## Heavy Ion, Single Event Effects (SEE) Final Report for Cypress Semiconductor CYRS15B102 Serial SPI FRAM 2-Mbit (256K X 8)

Date: 3 Aug 2021

## **1.0 Test Overview**

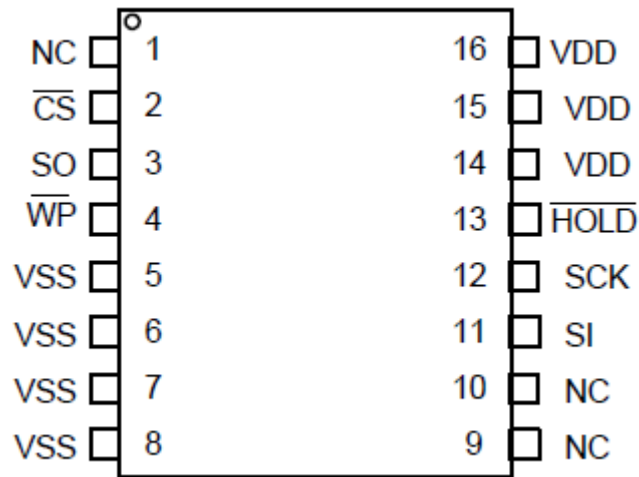
Parts were provided in 16 pin ceramic SOC packages with pinout as shown in Figure 2.

**Figure 2. 16 Pin Ceramic SOC Package and PinOut for CYRS15B102, 2Mb FRAM**

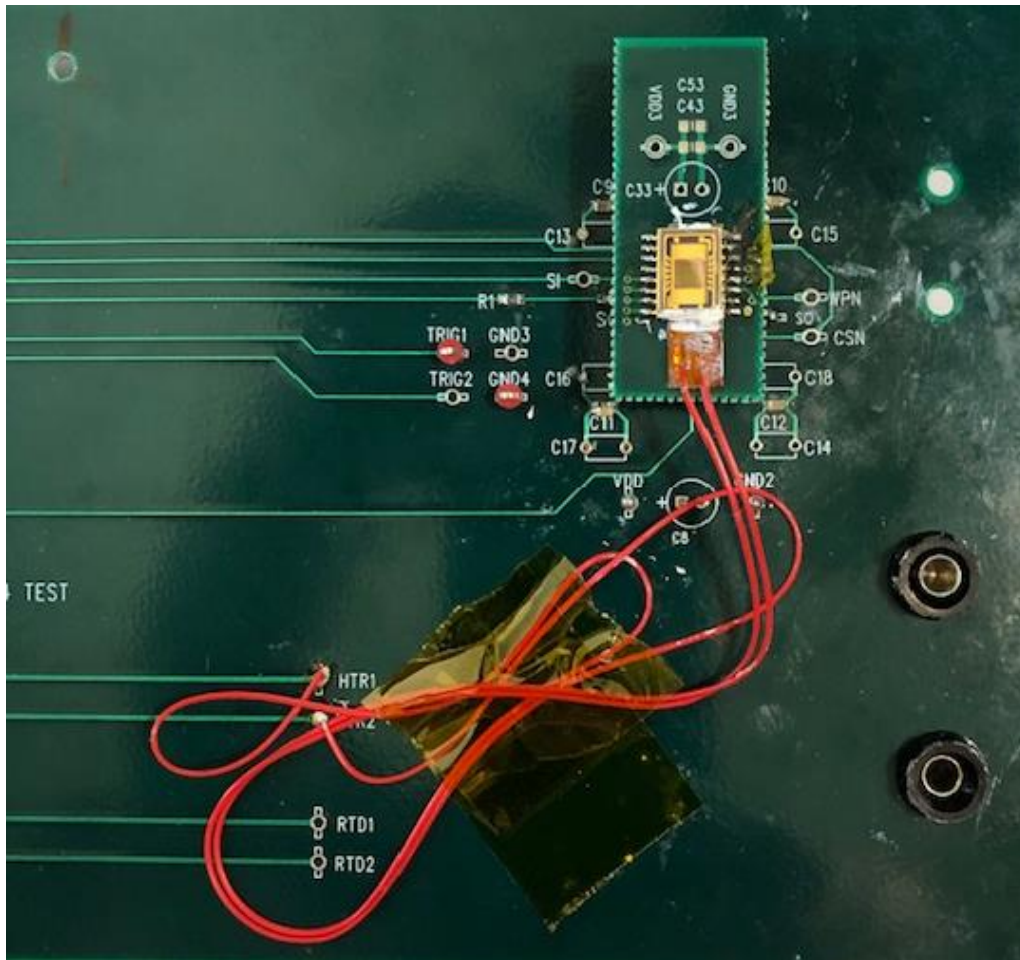
DUTs were mounted on small carrier cards for ease of handling and inserted into sockets on the test card. The DUT was heated by installing a heater strip underneath the DUT as shown in Figure 3.

**Figure 3. De-Lidded DUT on Carrier Card with Heat Strip Underneath**

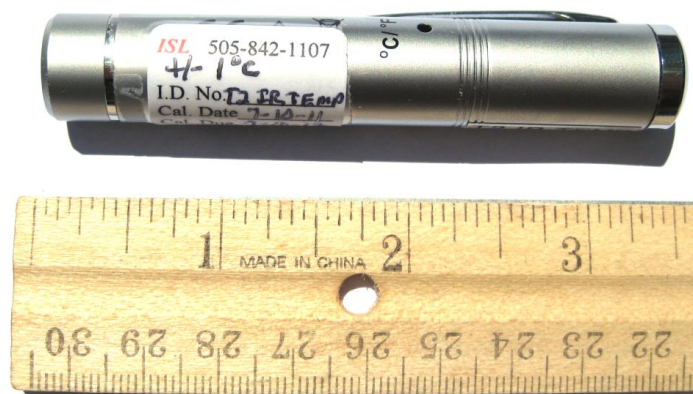
DUT temperature was monitored using an IR temperature sensor as shown in figure 4.

**Figure 4. I.R. Temperature Sensor**

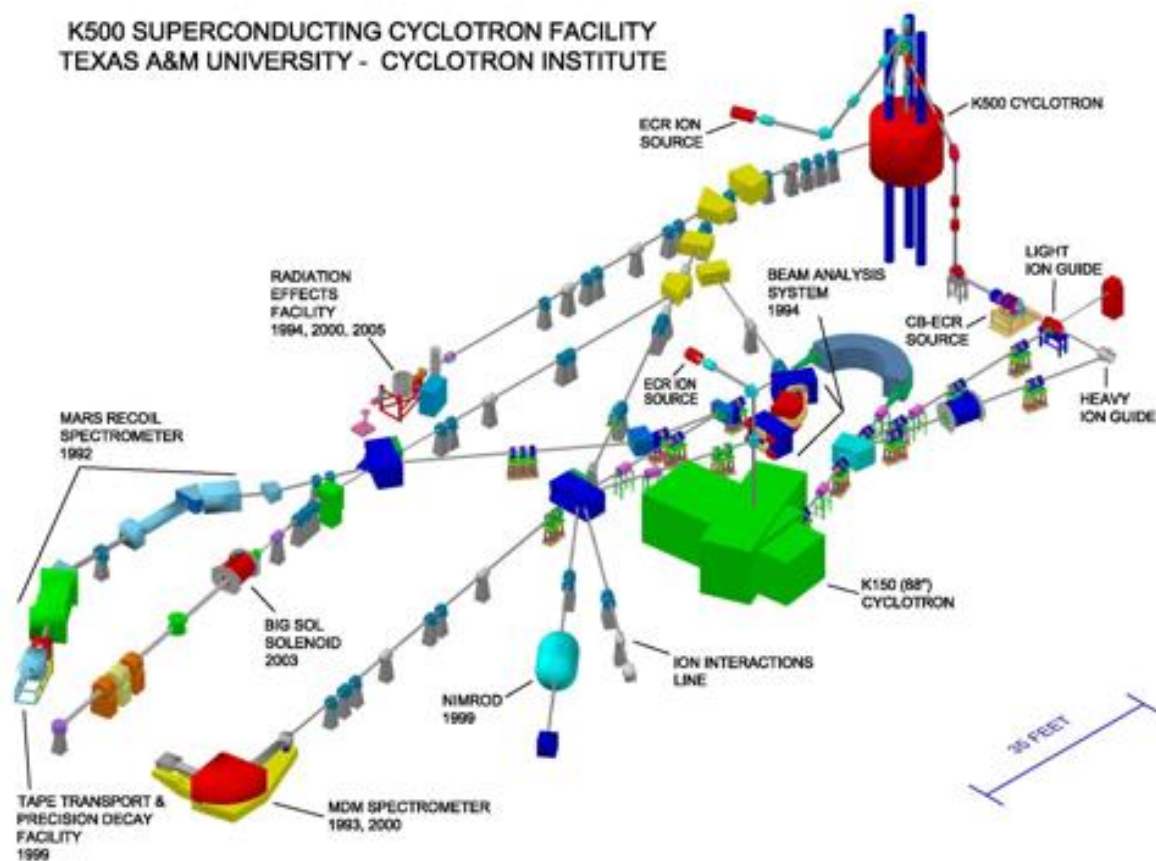
An overview of the TAMU cyclotron facility is shown in figure 5. Devices were mounted to a test board positioned in air in front of the beam exit at the “radiation effects facility” location shown in the figure.

**Figure 5. Overview of Texas A&M Cyclotron Facility (TAMU)**

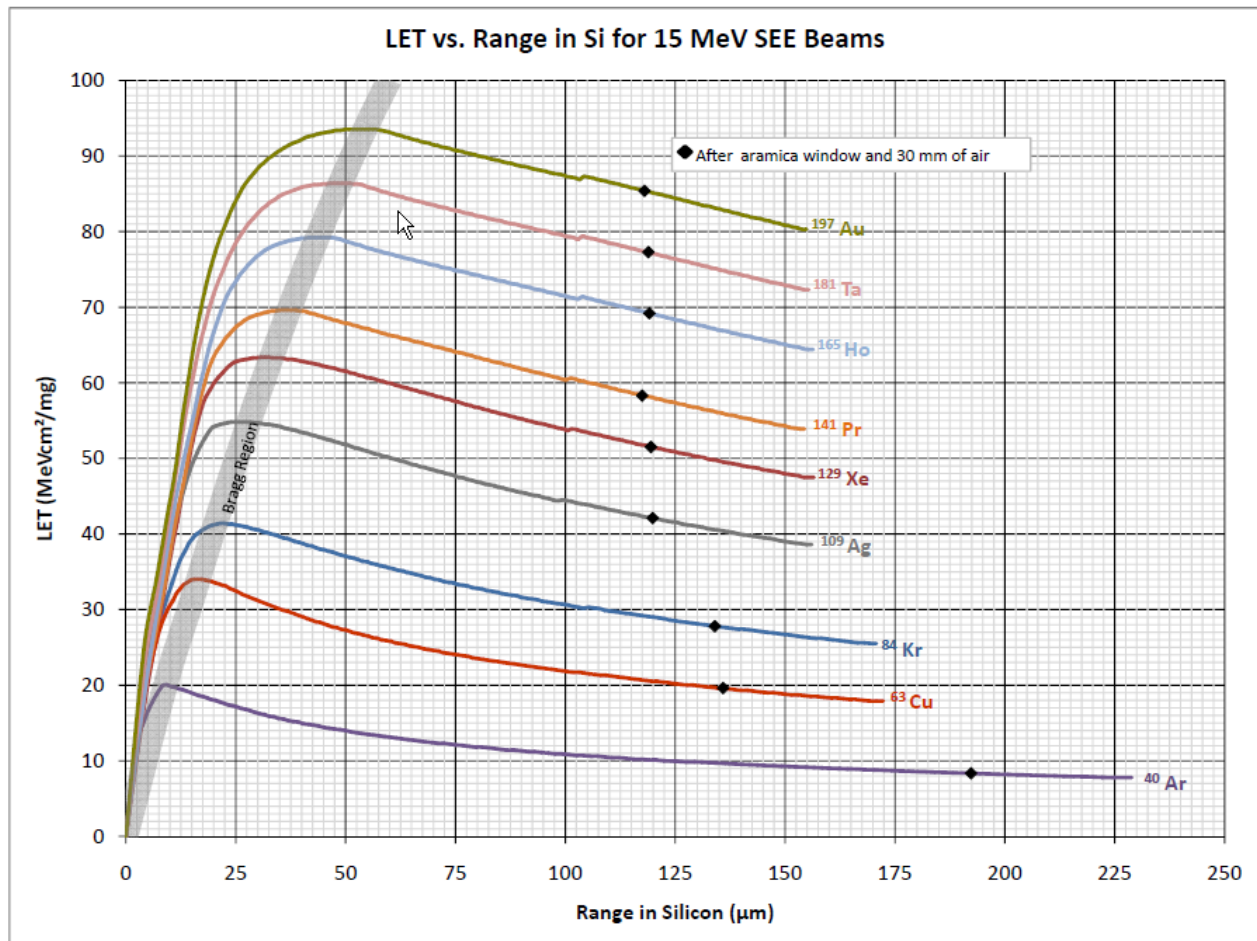
All irradiations were performed using the 15MEV tuning of the cyclotron. Figure 6 shows ions available for this tuning

Figure 6. TAMU Ions Available with 15MeV Tuning

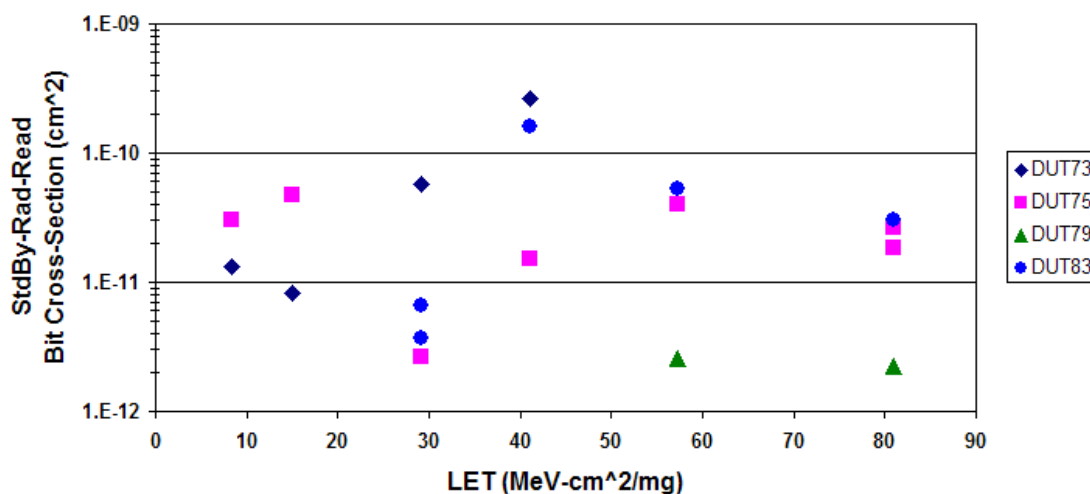
In normal operation a memory will be loaded with information, power will be maintained constantly and the part will be periodically read. During this campaign parts were tested using this profile and the associated runs were labeled "StdBy-Rad-Read". Figure 12 shows the resultant bit upset cross-sections when parts were tested using this profile.

**Figure 12. Bit Upset Cross-Sections, Normal Operation**

This plot is somewhat confusing until the effects of radiation on supporting CMOS circuitry is considered.

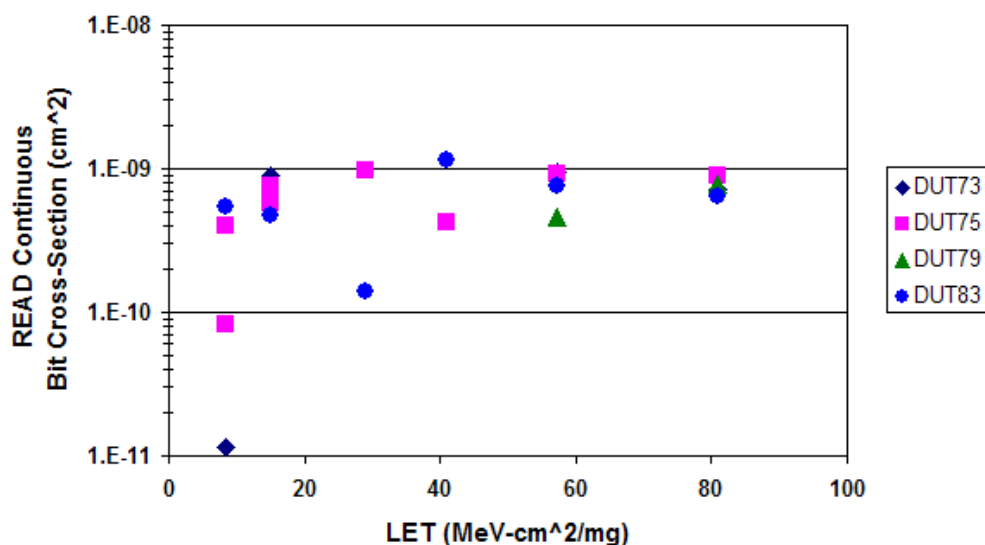
This information can be plotted as follows. First, the bit upset cross-sections for all runs is shown in Figure 17.

Figure 17. Bit Upset Cross-Sections for READ CONTINUOUS Tests

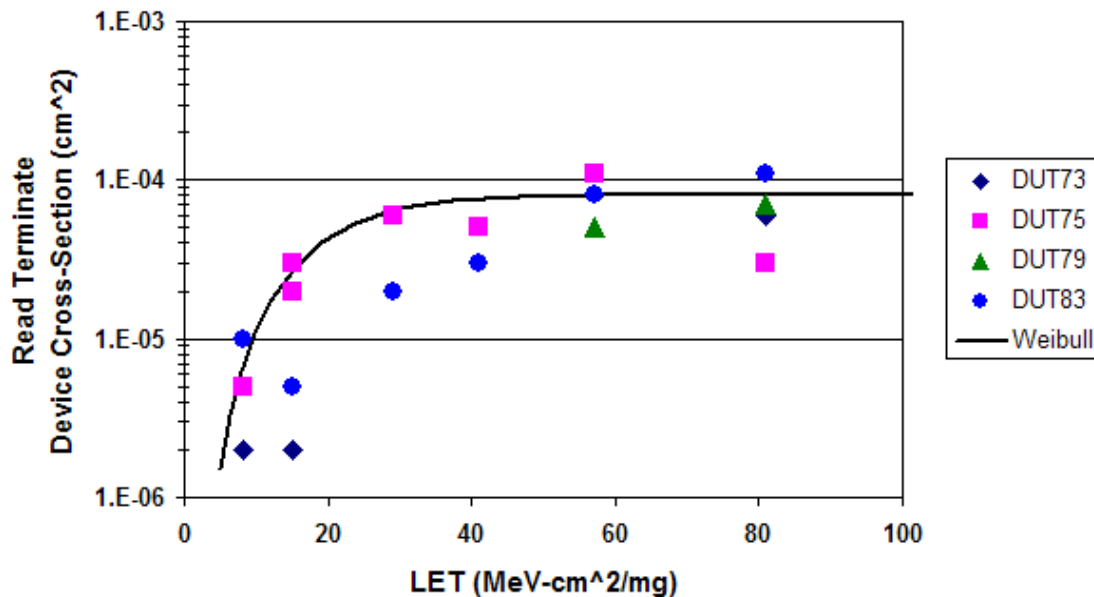
Figure 18 is a plot of device cross-sections for the READ TERMINATE SEFIs.

**Figure 18. Device Cross-Sections for  
“READ TERMINATE” SEFIs**

A Weibull curve for this type of SEFI is included on the plot. Parameters for this curve are shown in figure 19 below:

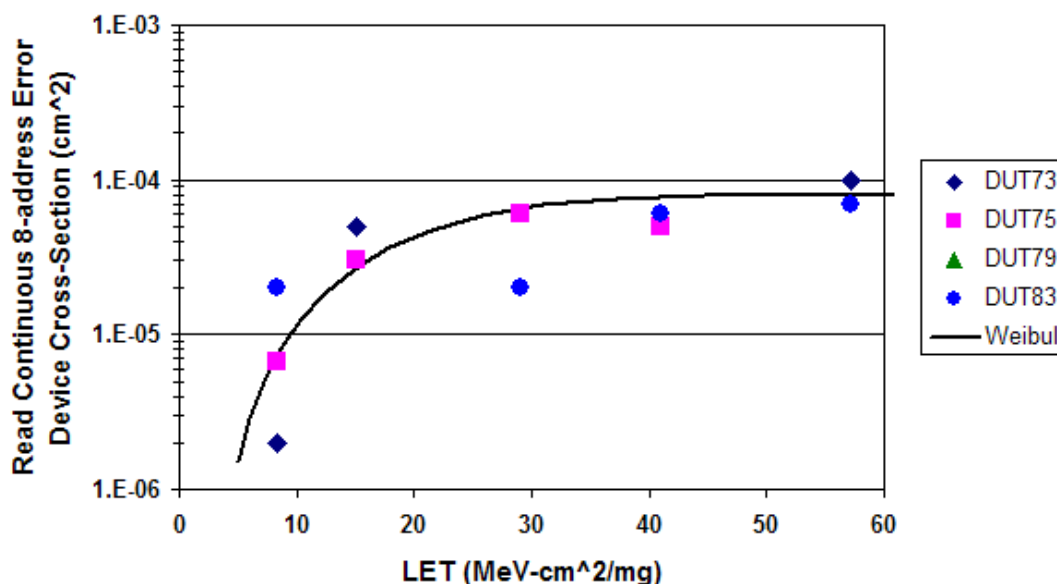
Figure 20 is a plot of device cross-sections for the occurrence of “8-Address” upsets. A Weibull curve is also shown on this plot using the same parameters listed above.

**Figure 20. Device Cross-Sections for  
"8-Address" Upsets**
