Spec Title: IBIS4-14000 FREQUENTLY ASKED QUESTIONS - AN6020

IBIS4-14000 Frequently Asked Questions - AN6020

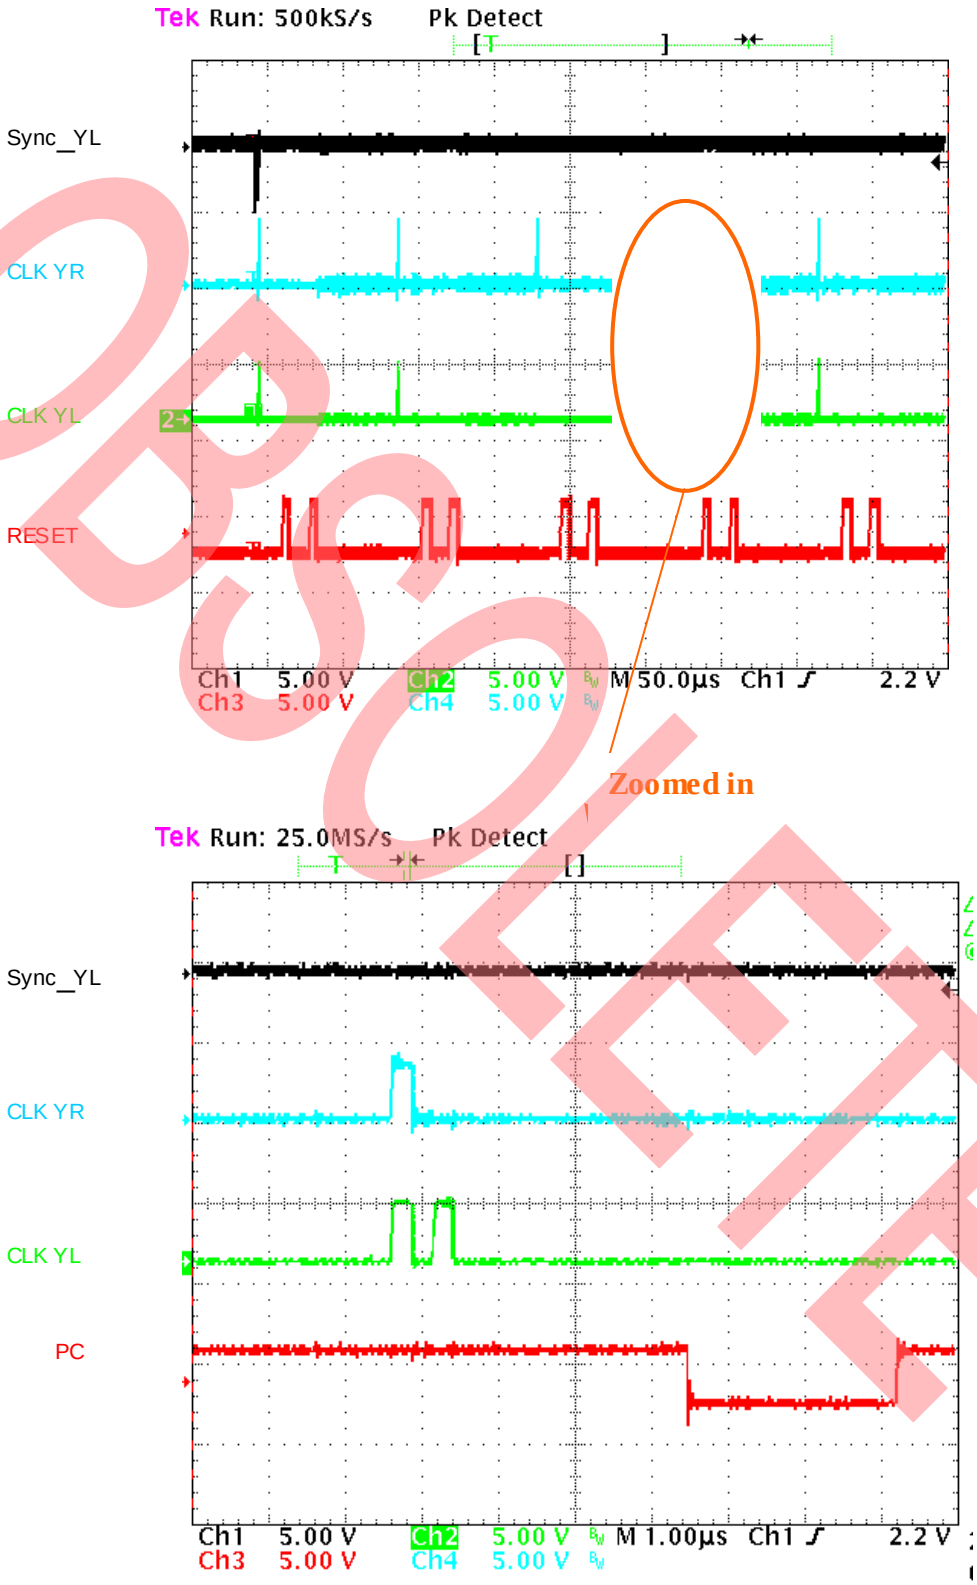
Figure 2. Modified Timing; in this case line 3 is defect and skipped

Figure 2 shows the timing that should be used when a line is defect. The timing assumes that the third line is defect.

The moving line problem can be solved by not reading out the defect line. This can be done by reading out the line before the defect line twice (suppressing of the CLK_YL pulse). When the line before the defect is readout twice, two succeeding CLK_YL pulses should be asserted. This way, the defect line is skipped and shall not influence the reset voltage of the row that is currently being reset.

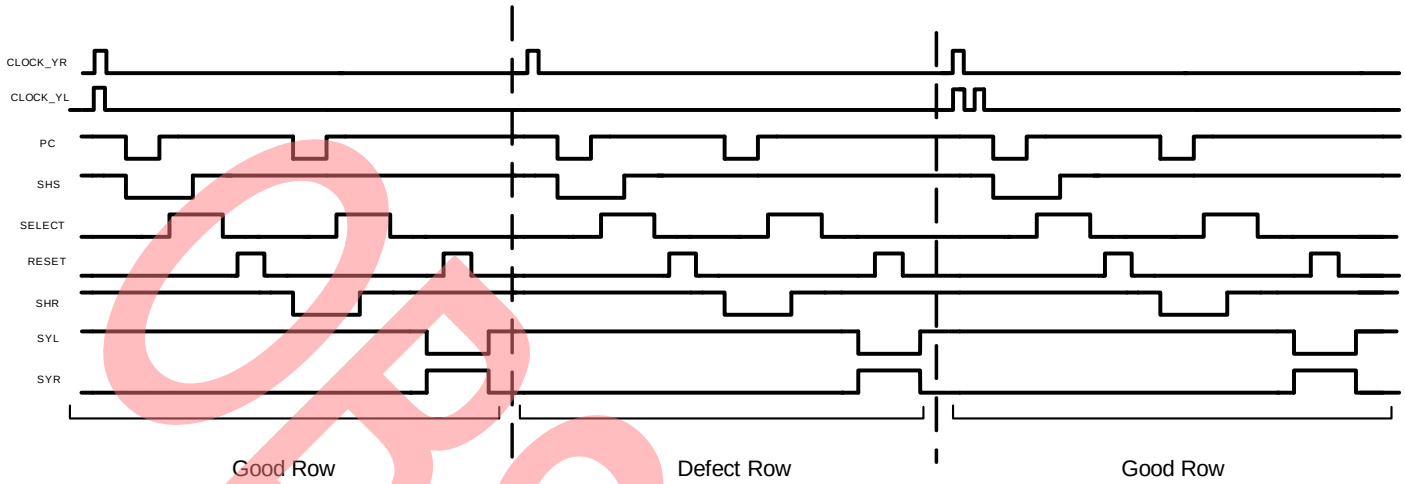
Figure 3. Modified Line Readout Sequence

Figure 3 shows the full line readout sequence with the modified timing. The row before the defect is readout twice (CLK_YL is suppressed). Two CLK_YL pulses after the same line has been readout will skip the defect line.

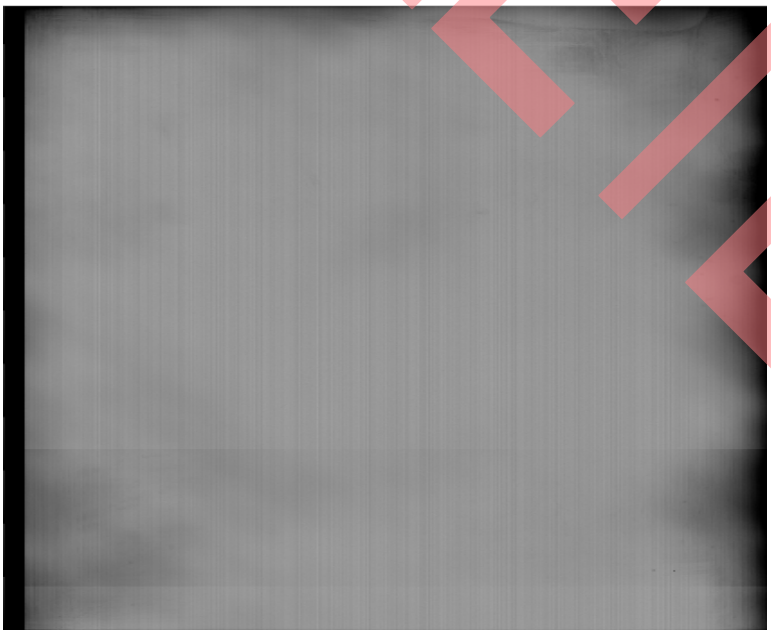
3. What is the cause of the banding in the image?

The banding is caused when vertical blanking is used to increase the integration time (delaying the assertion of SYNC_Y). When one of the Y-shift register points to the end of the image array, a SYNC_Y pulse will reset this shift register. If SYNC_Y is not asserted, the Y-shift register will be clocked out of the array while the other Y-shift register is still within the pixel array. This causes a voltage offset in the pixel. Both Y-shift registers should always be pointing in the array to eliminate this effect. When integration times longer than the frame readout time are required, one should apply horizontal blanking, i.e., program additional delay times at the end of each row. It is very important that the SYNC_Y and Y_CLOCK pulses are always asserted with the same interval.
