TC1766

32-Bit Single-Chip Microcontroller

TC1766 Documentation Addendum

Revision History: **V1.2 2007-04**

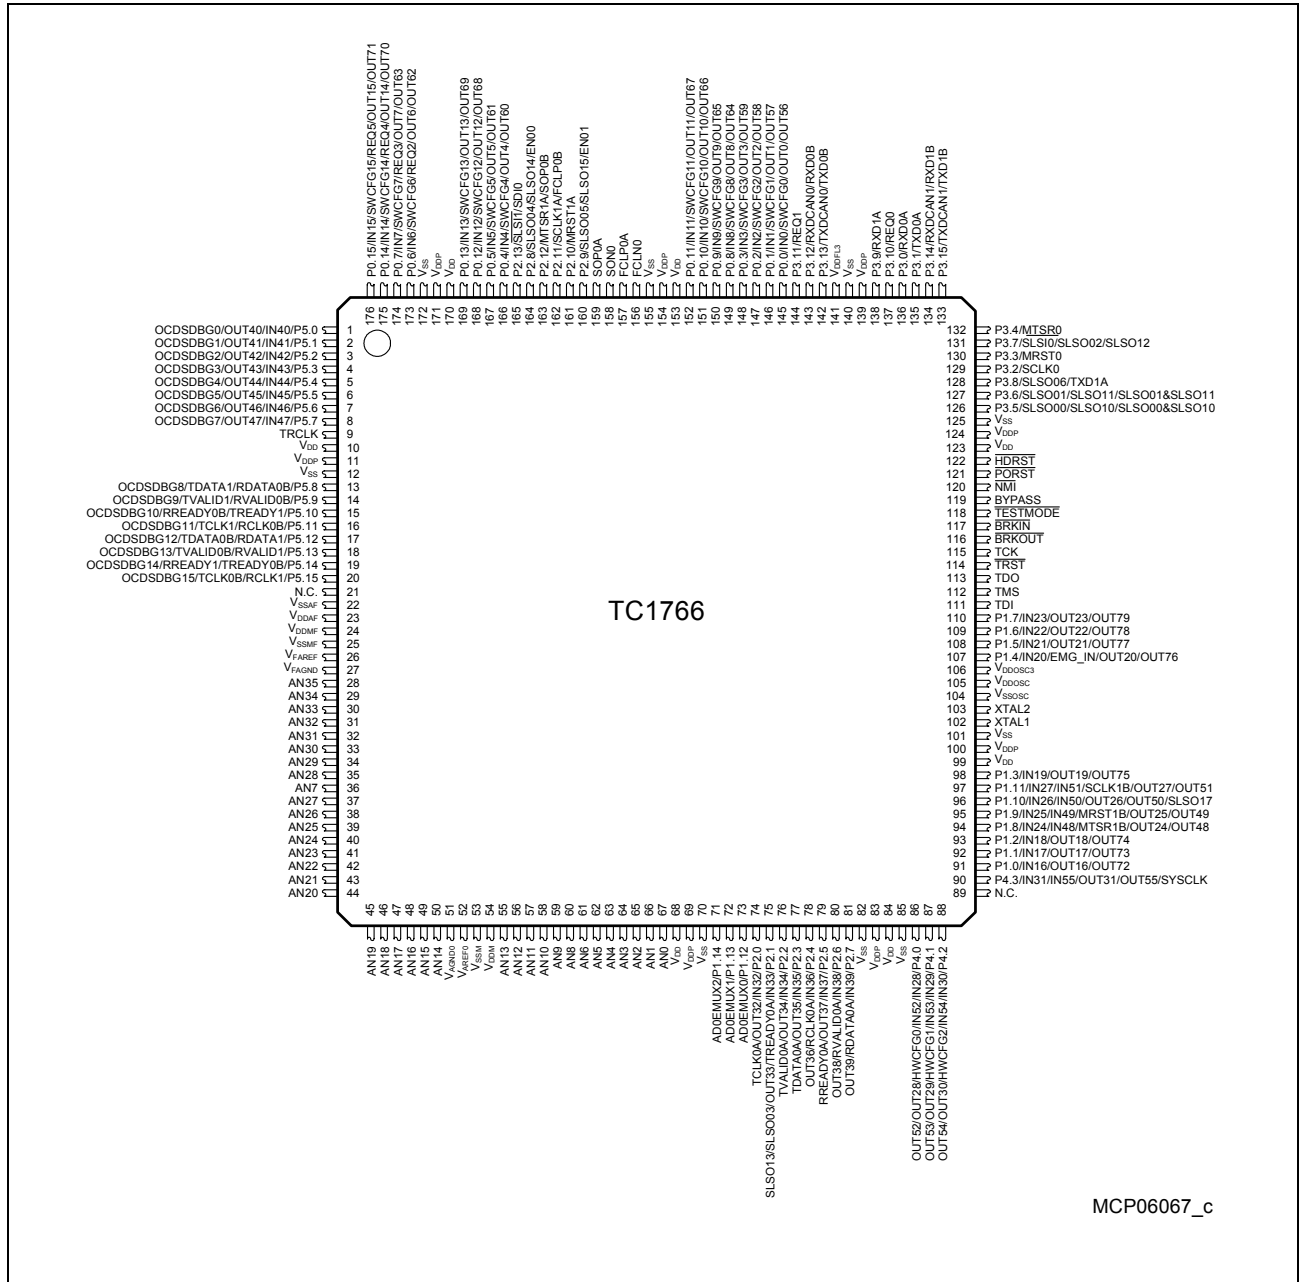
Figure 1-12 TC1766 Pinning for PG-LQFP-176-2 Package

The pad driver class of pin HDRST is “A2” instead of “A1”. The pad driver class of pin NMI and PORST are grouped as “A2”.

Page	Subjects (major changes since last revision)
7	Figure 1-12 is updated.
8	The register long names for MMU_CON and D11 to D15 are corrected.
10	The description for CRC generation and error checking is improved; the typo is corrected for EICR0.REN0, EICR0.REN1, EICR1.REN2 and EICR1.REN3
11	The typo of bit description GEEN1 is corrected.
19	The bit name and access type is corrected for bit 5 of PCP_ES register; the instruction field definition of Table 10-12 is updated.
20	Figure 10-14 is updated; the typo in the syntax description of the ST.PI instruction of the PCP is corrected
21	The typo in Figure 11-5 is corrected.
22	The description for Channel Reset Operation is improved.
23	The typo in Transaction Lost Interrupt section is corrected.
24	The typo in Move Engine Interrupt section is corrected.
28	The read and write access modes for address location F000 0804 _H of Table 16-7 are corrected; the reserved column for address location F000 0850 _H to F000 08F4 _H of Table 16-7 are split.

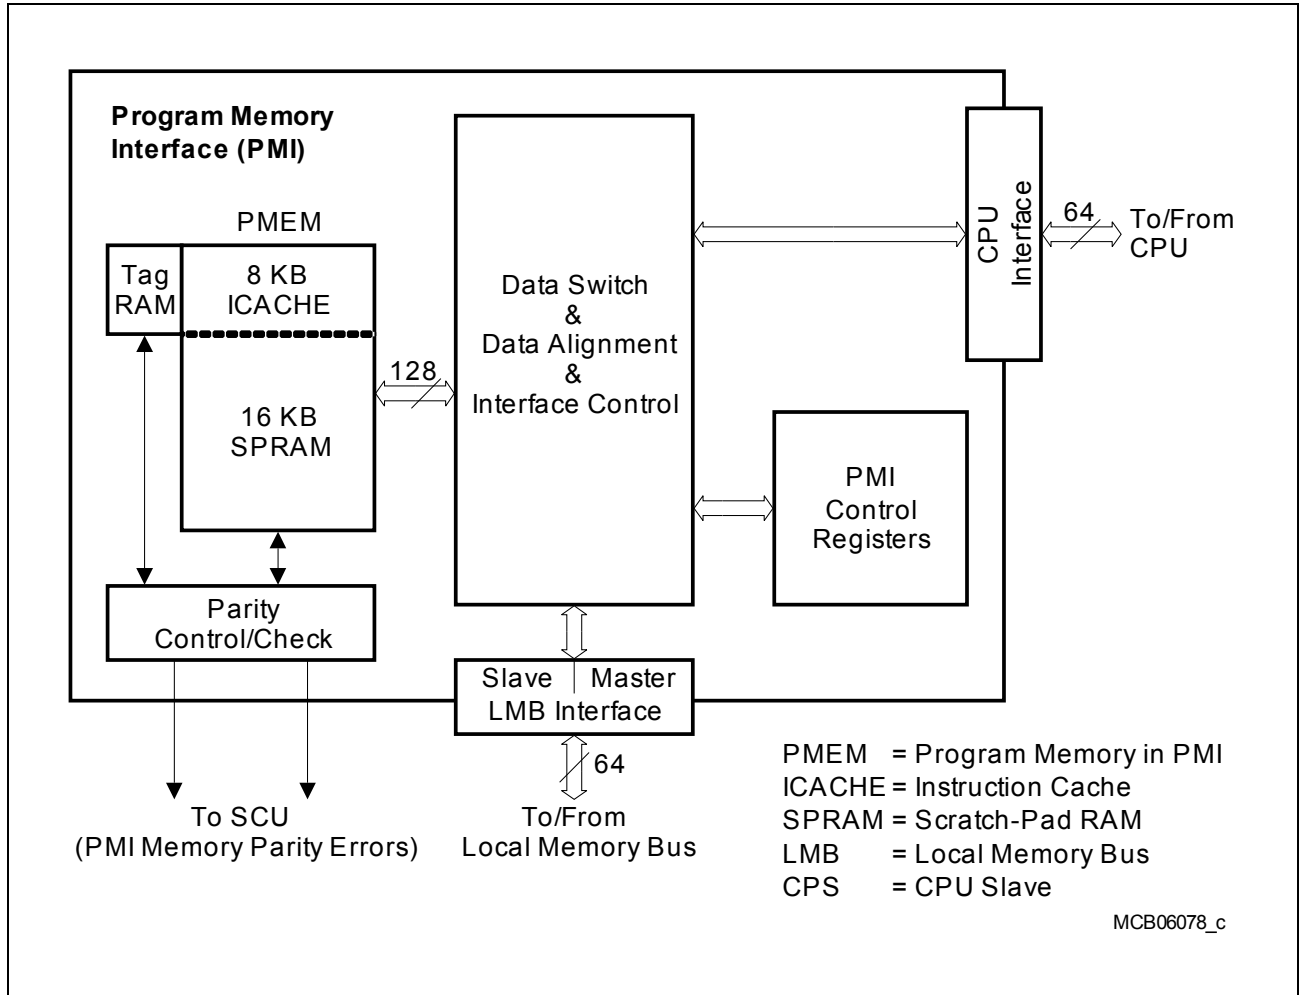
Figure 2-11 PMI Block Diagram

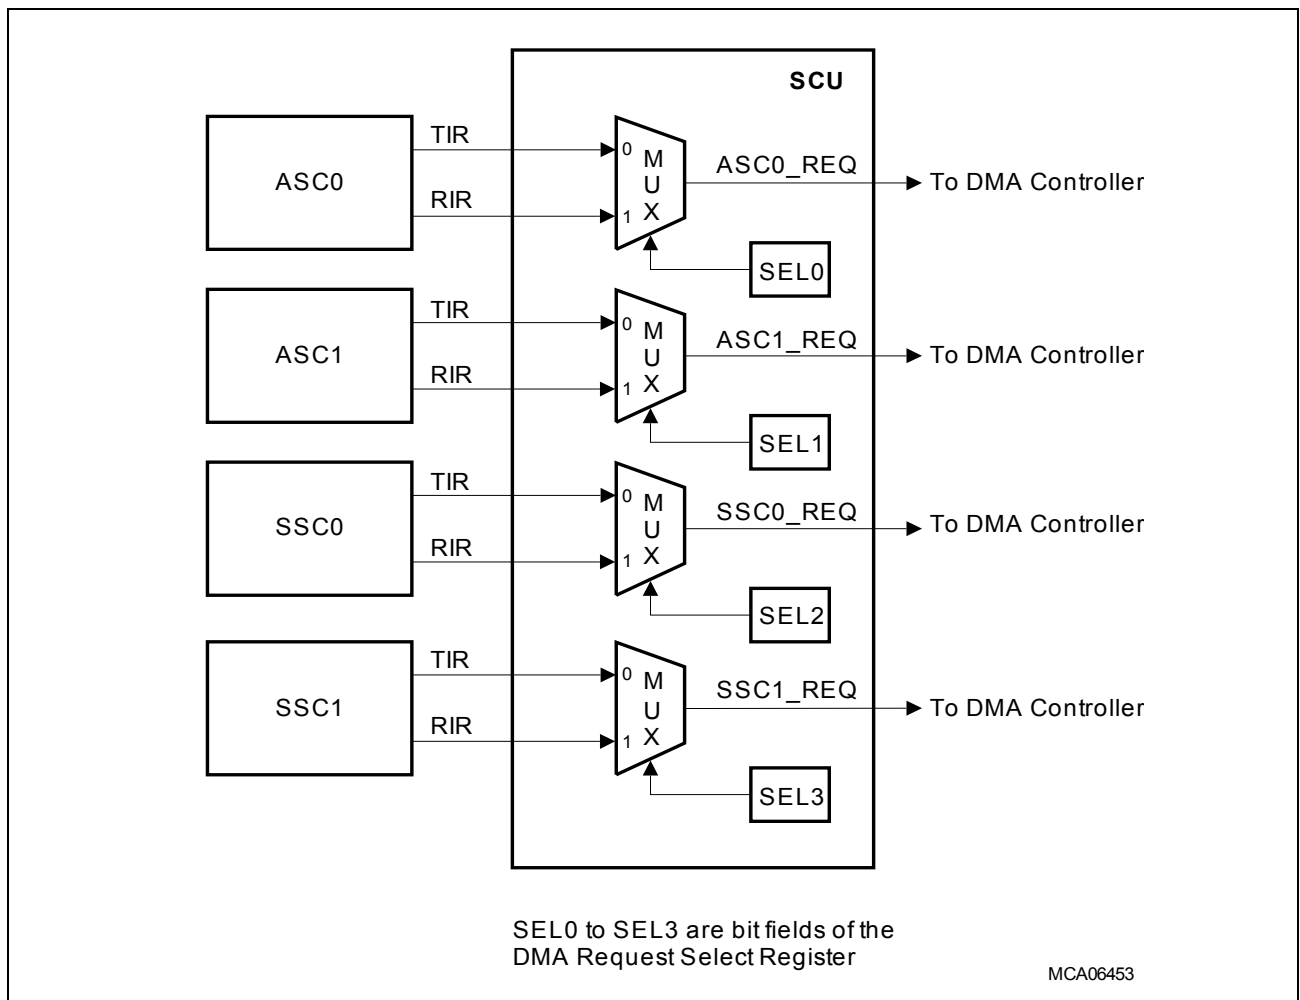
Figure 5-11 DMA Request Selection Logic

Note: By default, TIR line is selected for both ASC and SSC modules. For RIR line to be selected, SEL0.DMARS to SEL3.DMARS should be set accordingly. See DMARS register.

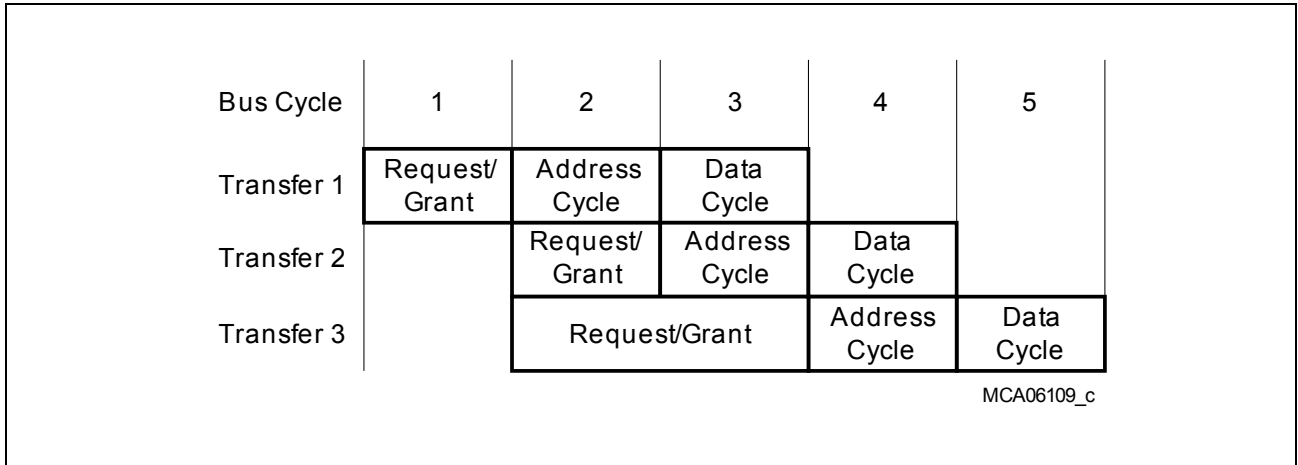
Figure 6-7 Basic FPI Bus Transactions

The second sentence of the first paragraph of Section 6.4.3 should be replaced with: "The requesting FPI Bus master releases the FPI Bus for one cycle after the FPI Bus transaction request, in order to allow the FPI Bus slave to indicate if it is ready to handle the requested FPI Bus transaction."

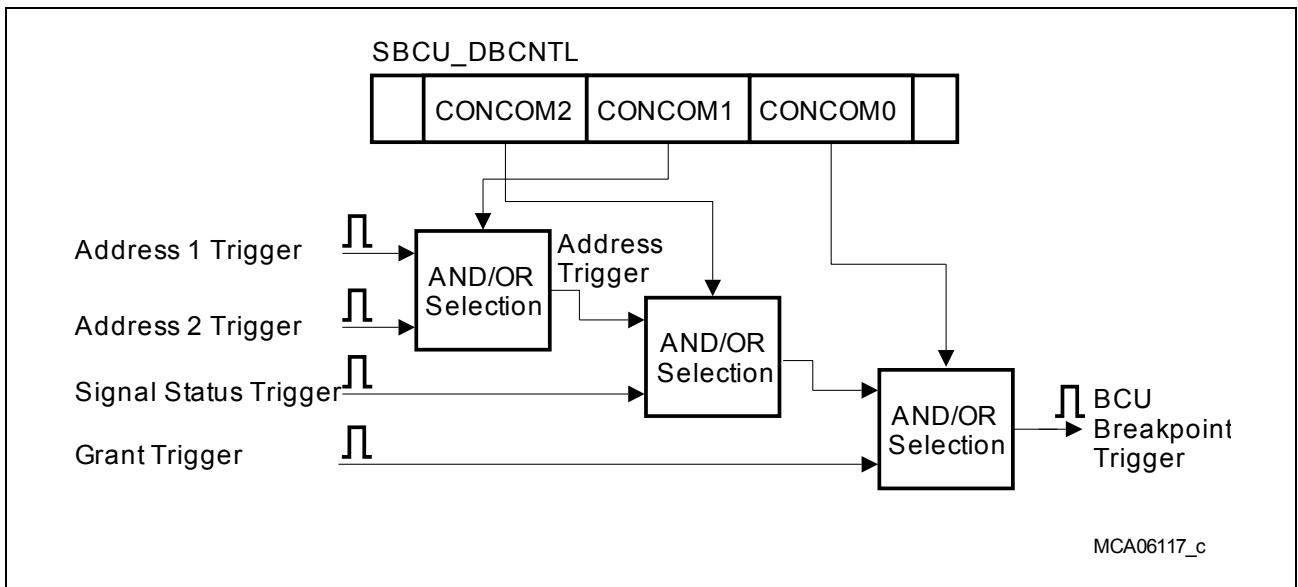
Figure 6-12 BCU Breakpoint Trigger Combination Logic

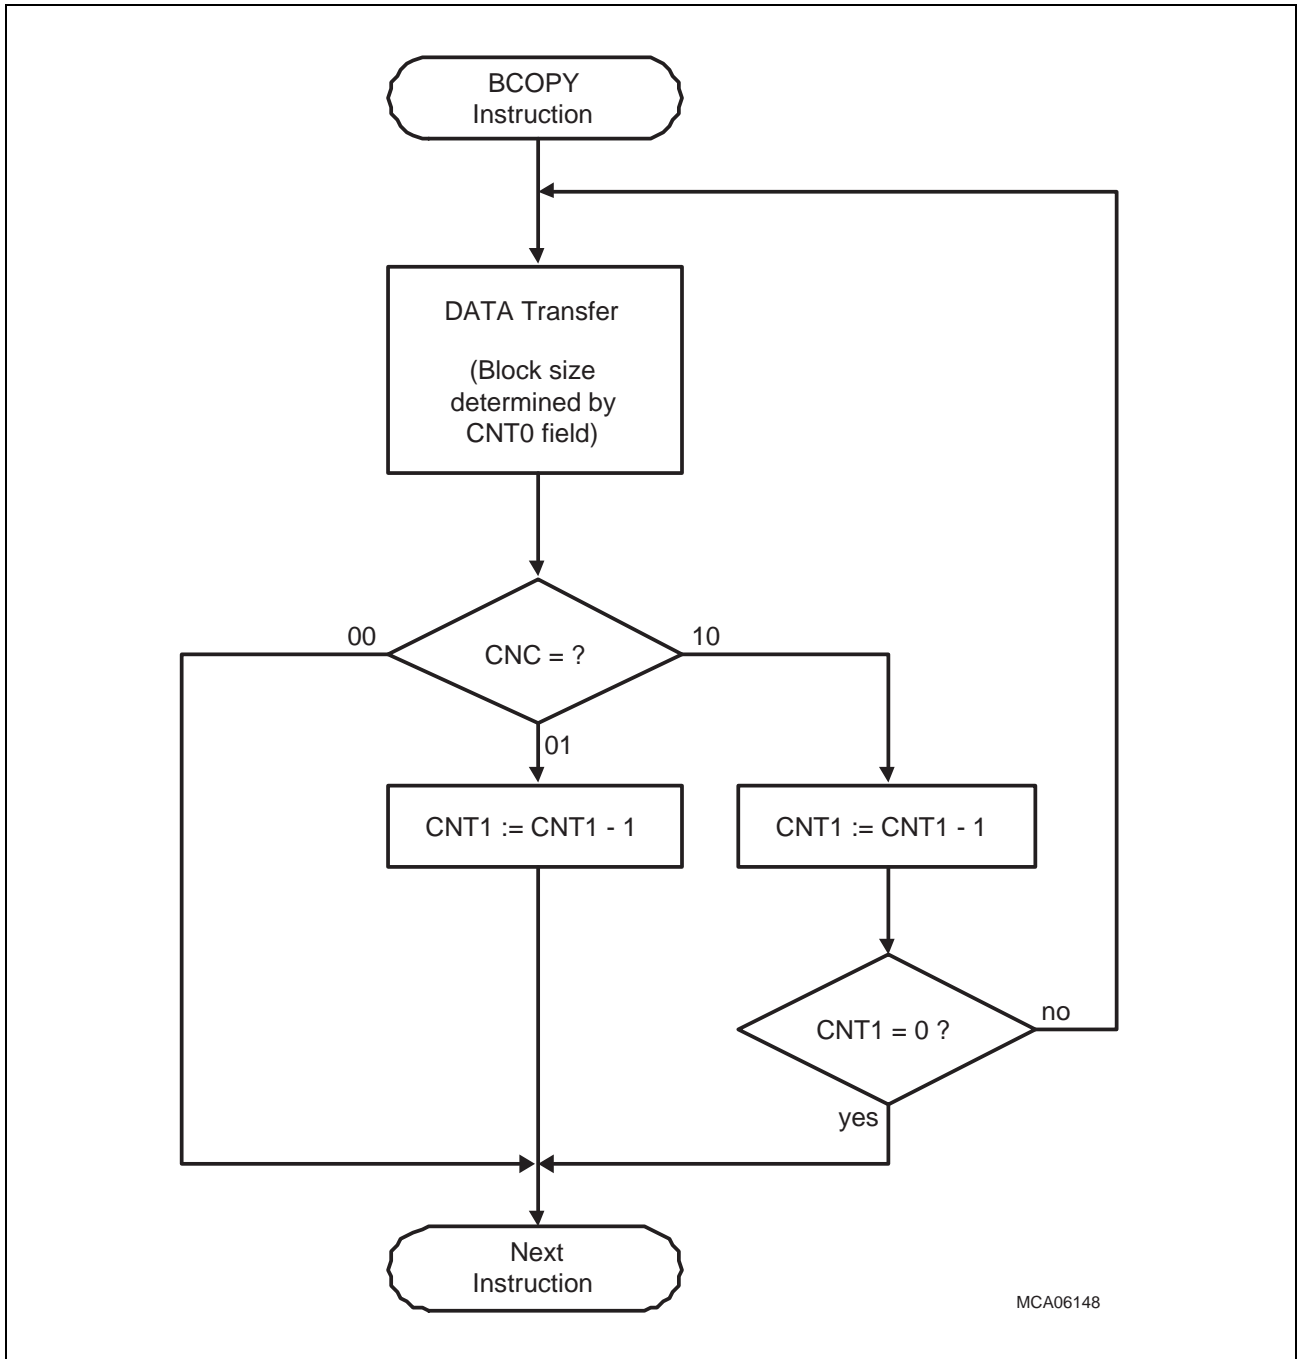
Figure 10-14 must be replaced by the following figure (block "DATA Transfer" has been changed):

Figure 10-14 Counter Operation for BCOPY Instruction

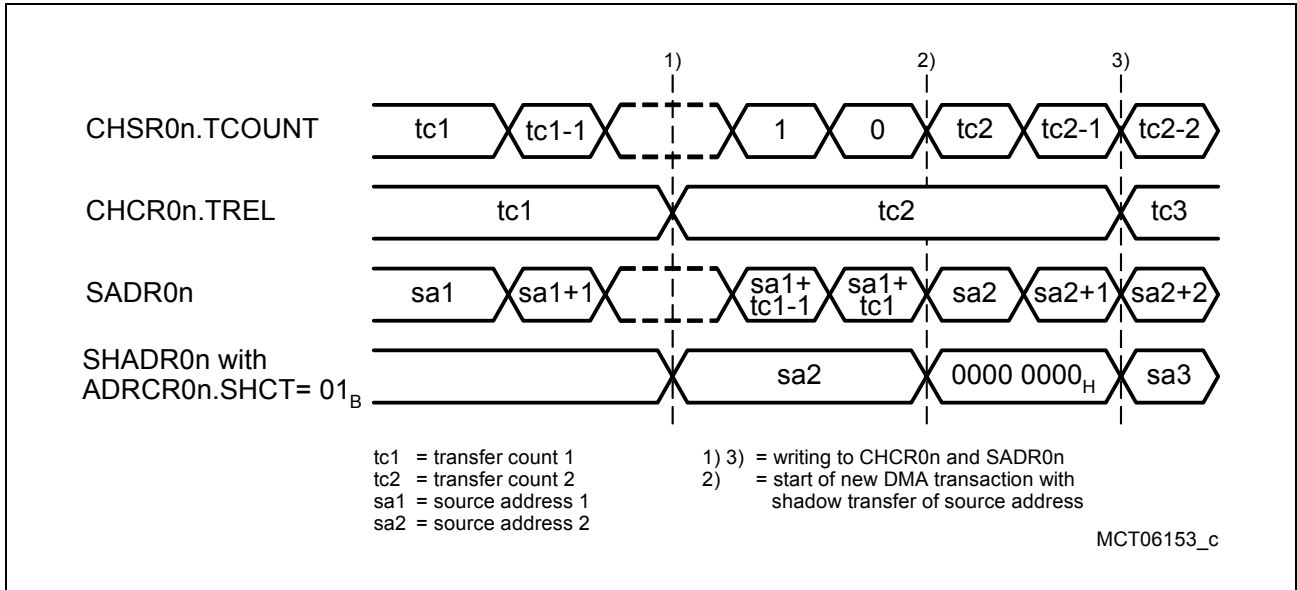
The wordings "SHADR0n with CHCR0n.SHCT = 01_B" on the left of the first waveform from the bottom of Figure 11-5 must be replaced with "SHADR0n with ADRCR0n.SHCT = 01_B".

Figure 11-5 Shadow Source Address and Transfer Count Update

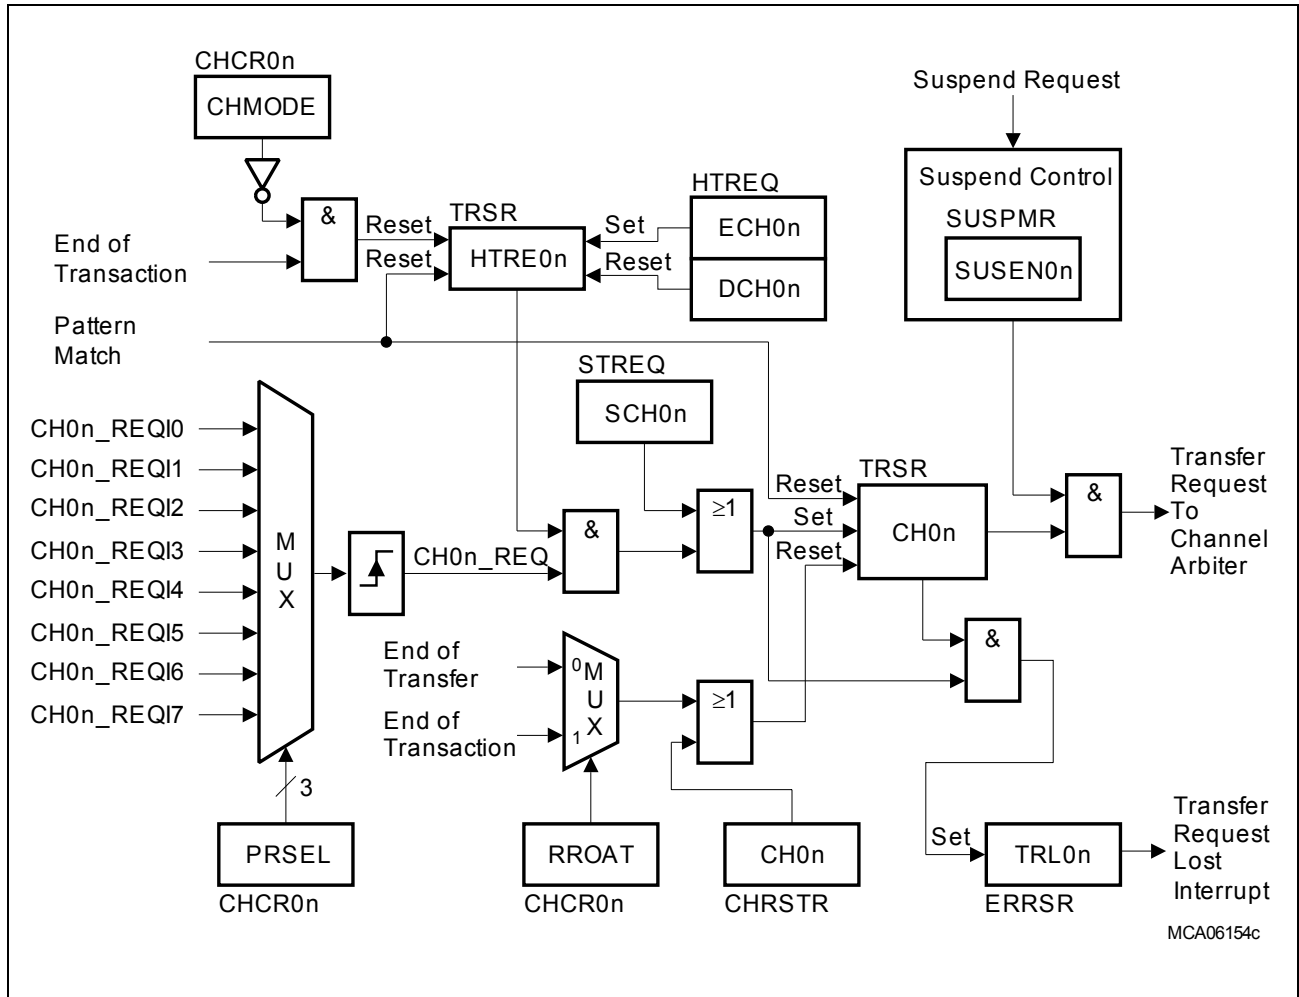
Figure 11-6 must be updated as per the corresponding changes on pages 11-35 and 11-50.

Figure 11-6 Channel Request Control

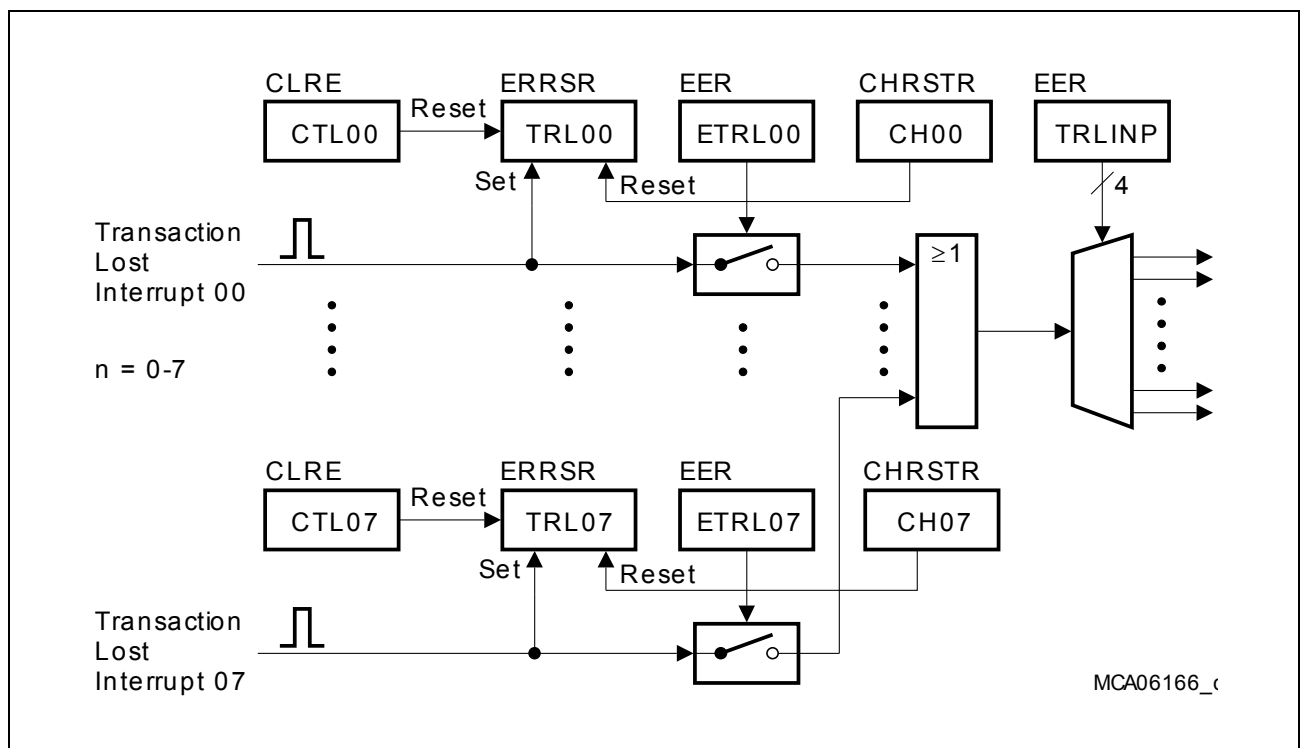
Figure 11-18 Transaction Lost Interrupt

In Section 11.1.8.2, the register name EERSR must be replaced by ERRSR in the third sentence of the first paragraph, first sentence of the second paragraph and within Figure 11-18. The corresponding text must be replaced by :

“If such a transaction request lost condition occurs, bit **ERRSR.TRL0n** is set.” and “A transaction request lost condition of DMA channel 0n is indicated by status flag **ERRSR.TRL0n**, which can be reset by setting bit **CLRE.CTL0n** or **CHRSTR.CH0n**.”

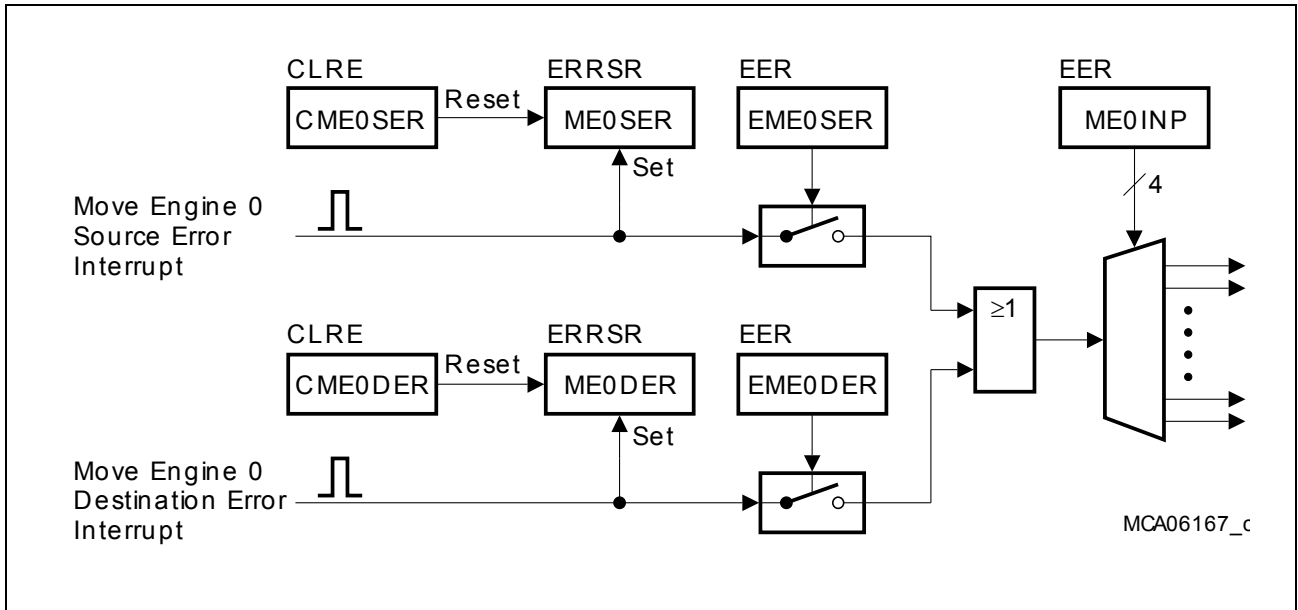
Figure 11-19 Move Engine Interrupts

In Section 11.1.8.3, the register name EERSR must be replaced by ERRSR in the first sentence of the third paragraph and within Figure 11-19. The corresponding text must be replaced by :

“A source error of Move Engine 0 is indicated by the status flag **ERRSR.ME0SER**.”

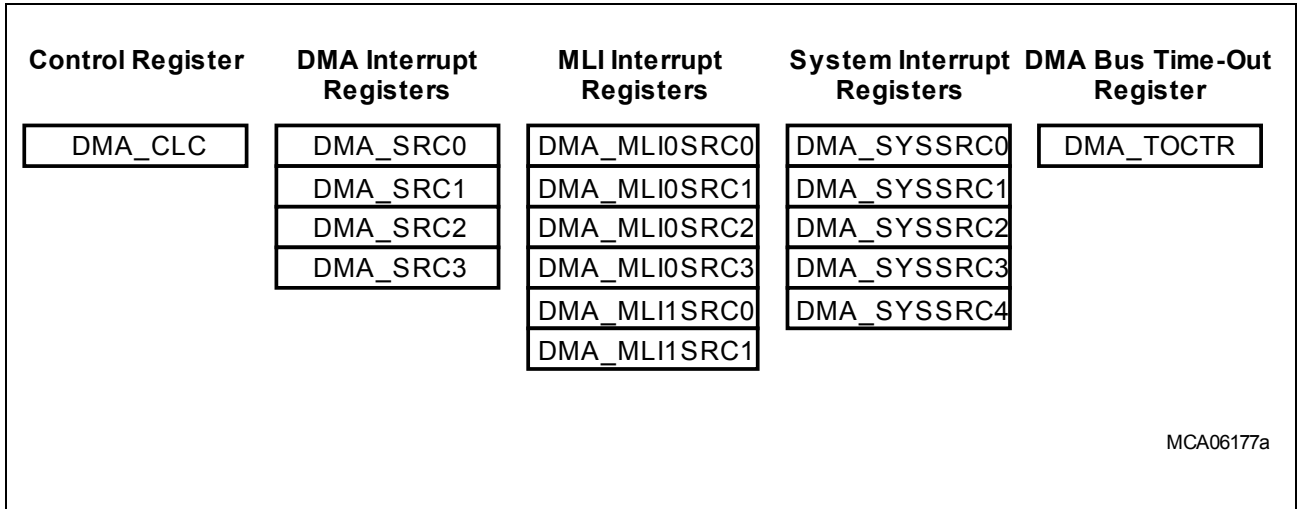
Figure 11-29 DMA Implementation-specific Registers

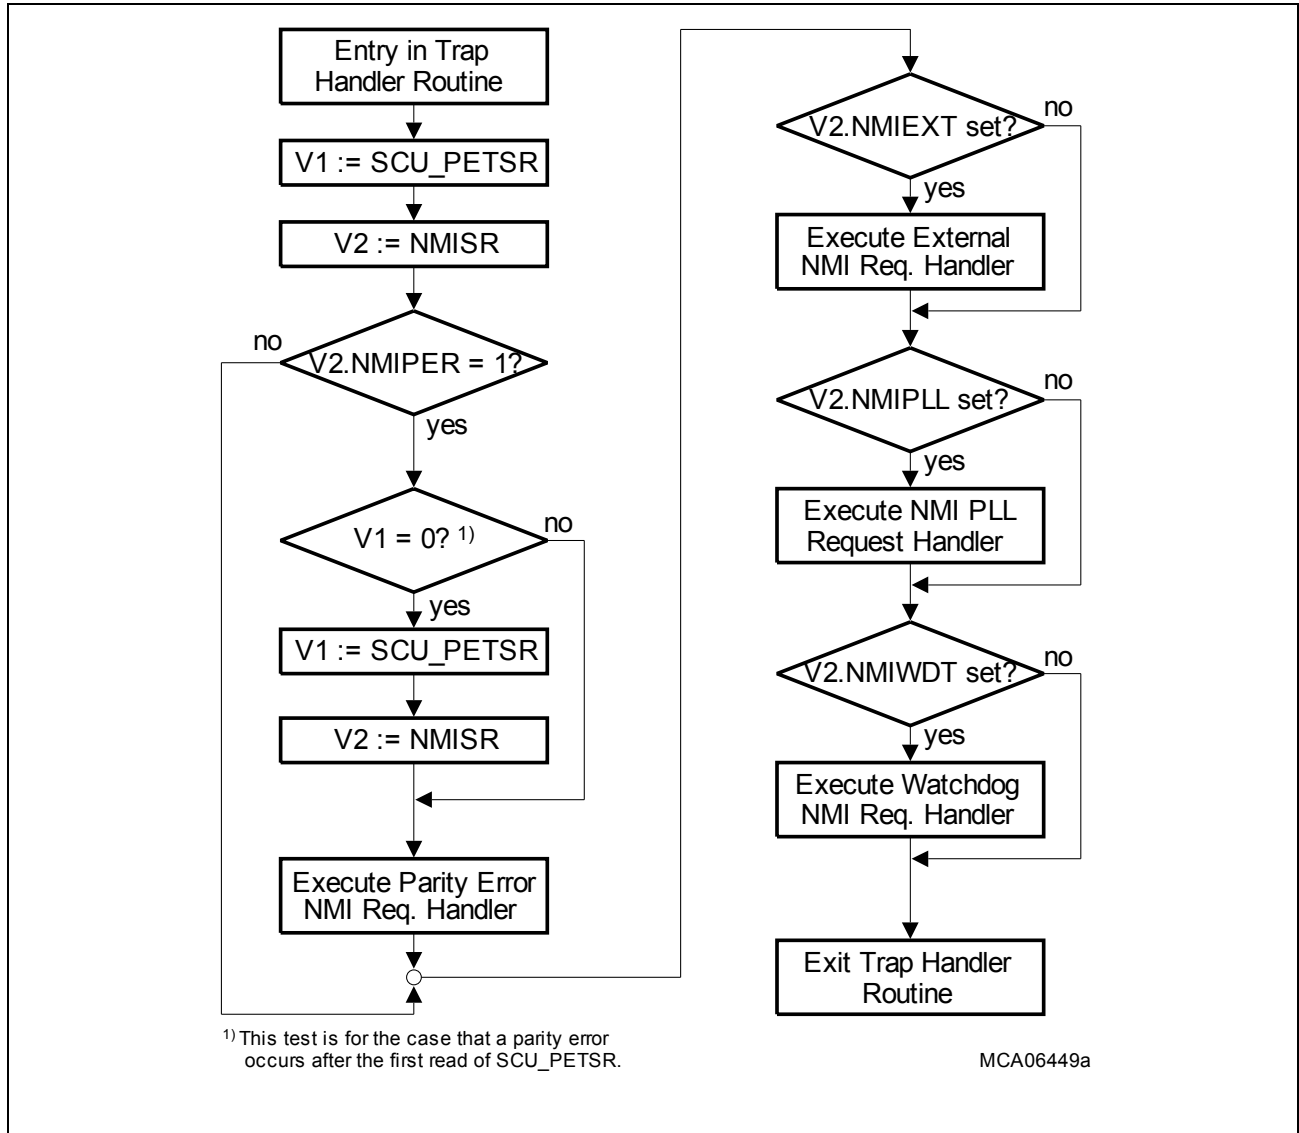
Figure 12-5 NMI Trap Handler Routine for Parity Error Handling

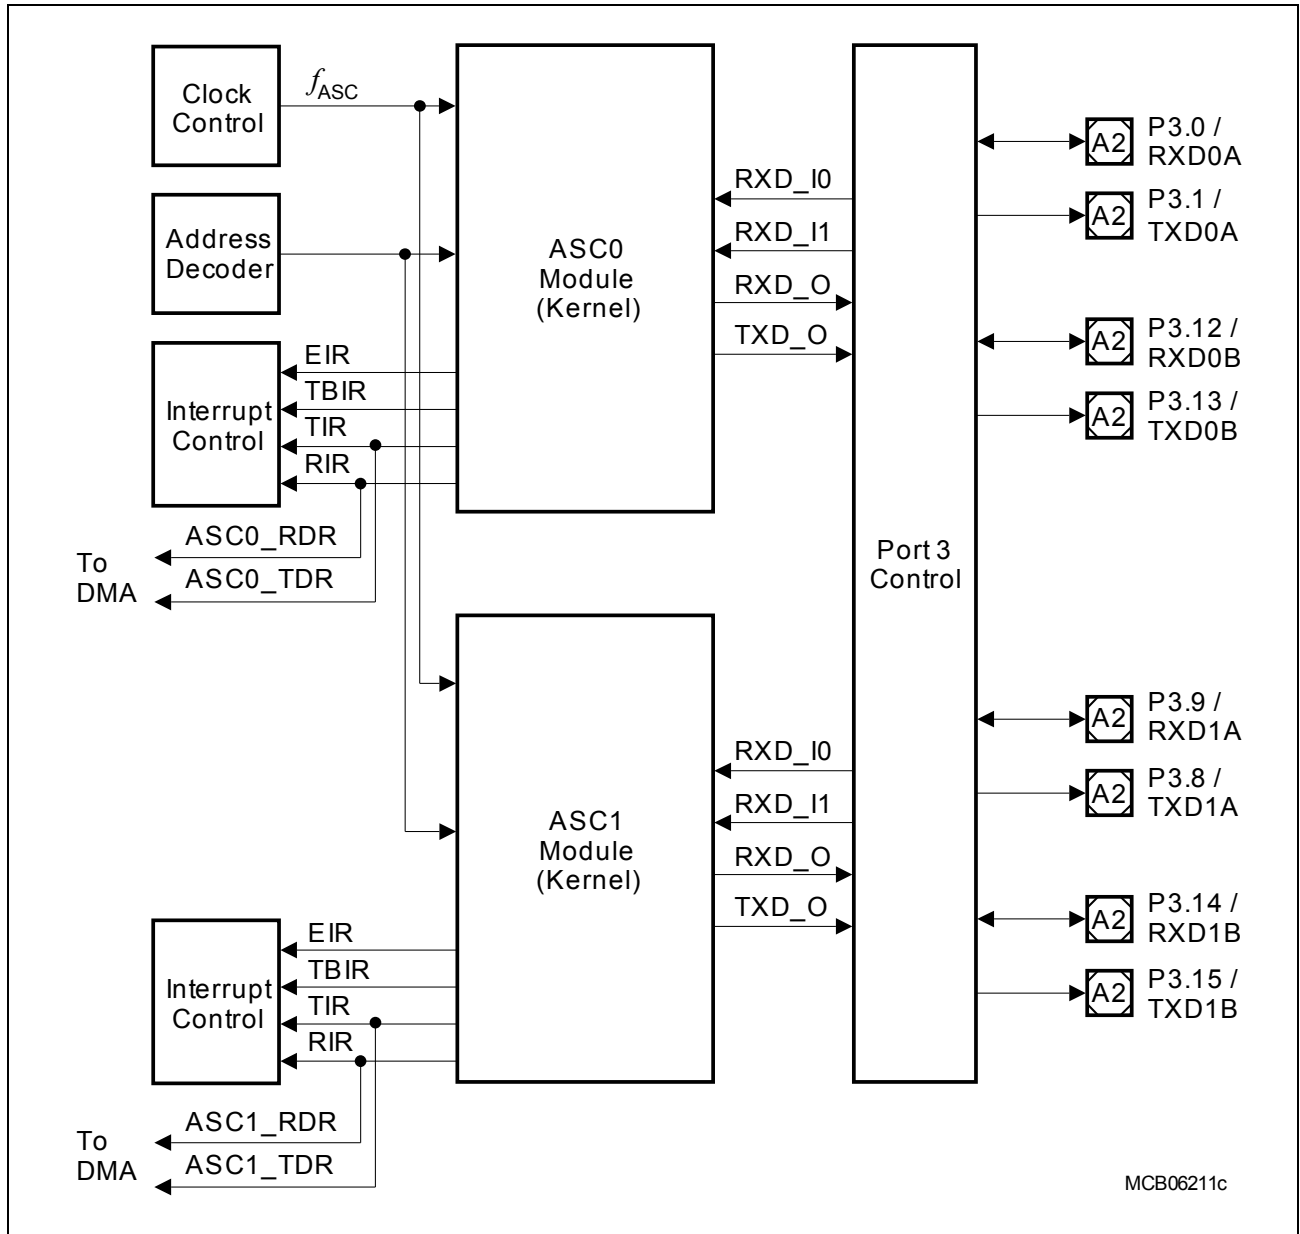
Figure 17-12 ASC0/ASC1 Module Implementation and Interconnections

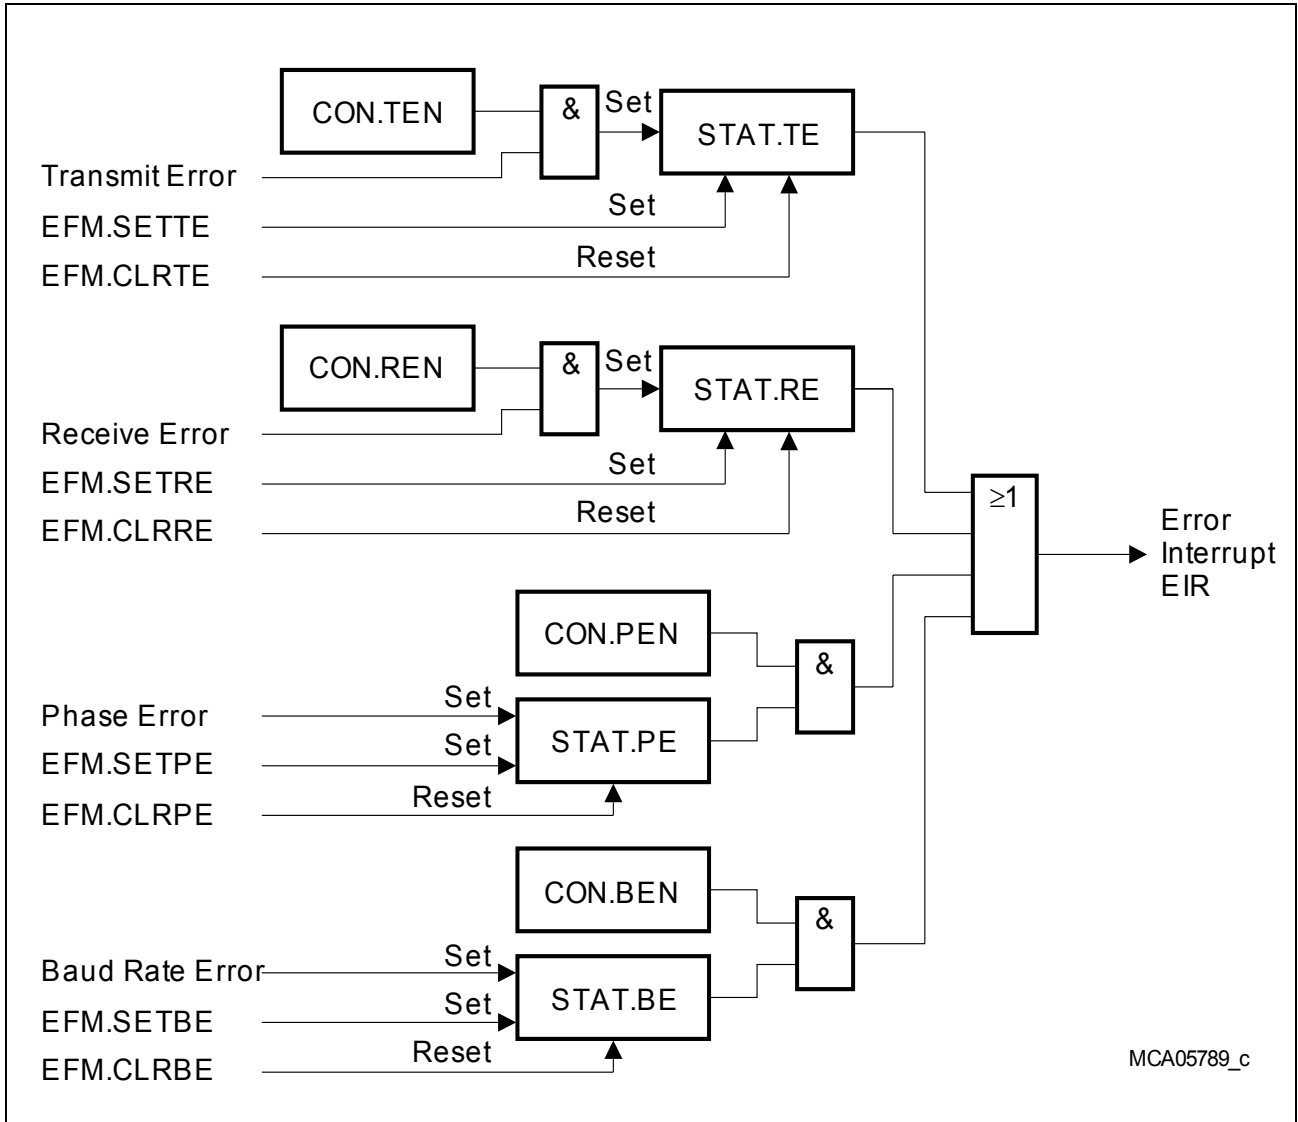
Figure 18-11 SSC Error Interrupt Control

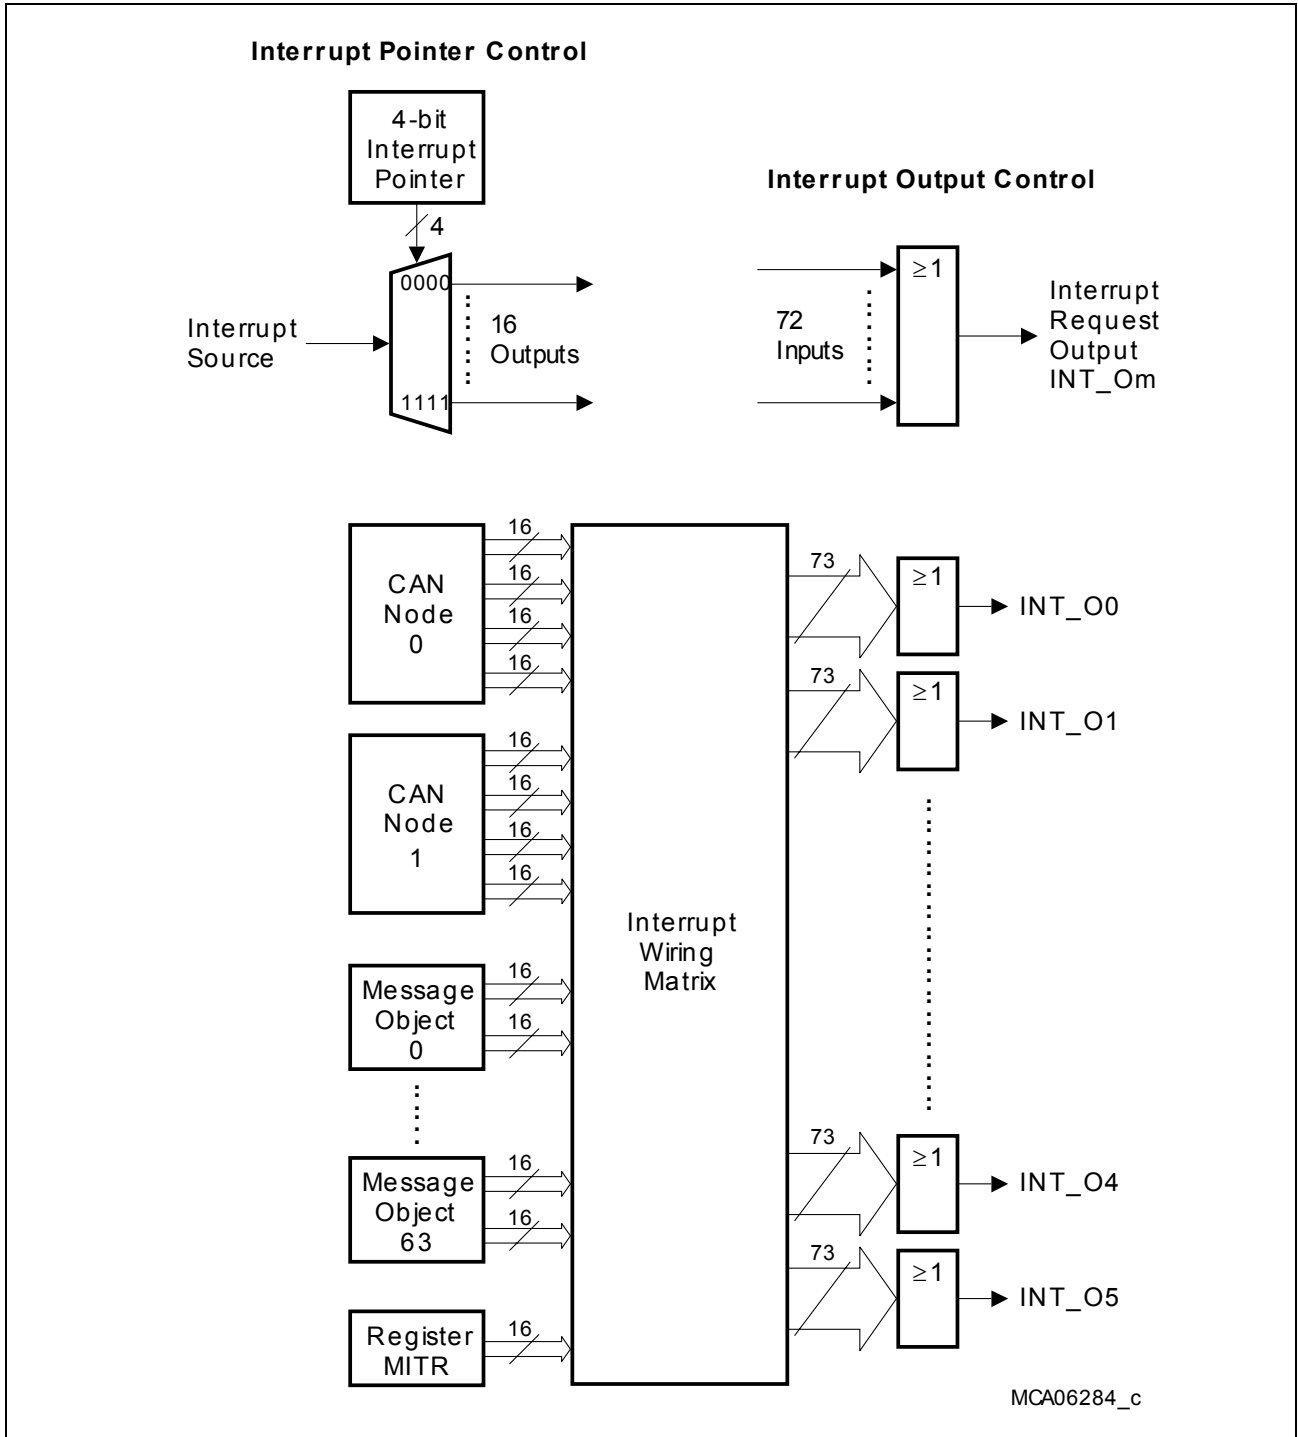
Figure 20-27 Interrupt Compressor

The first sentence of the second paragraph must be replaced by: "Each of the 136 hardware initiated interrupt sources is controlled by a 4-bit interrupt pointer that directs the interrupt source to one of the **six** interrupt outputs INT_{Om} (m = 0-5)."

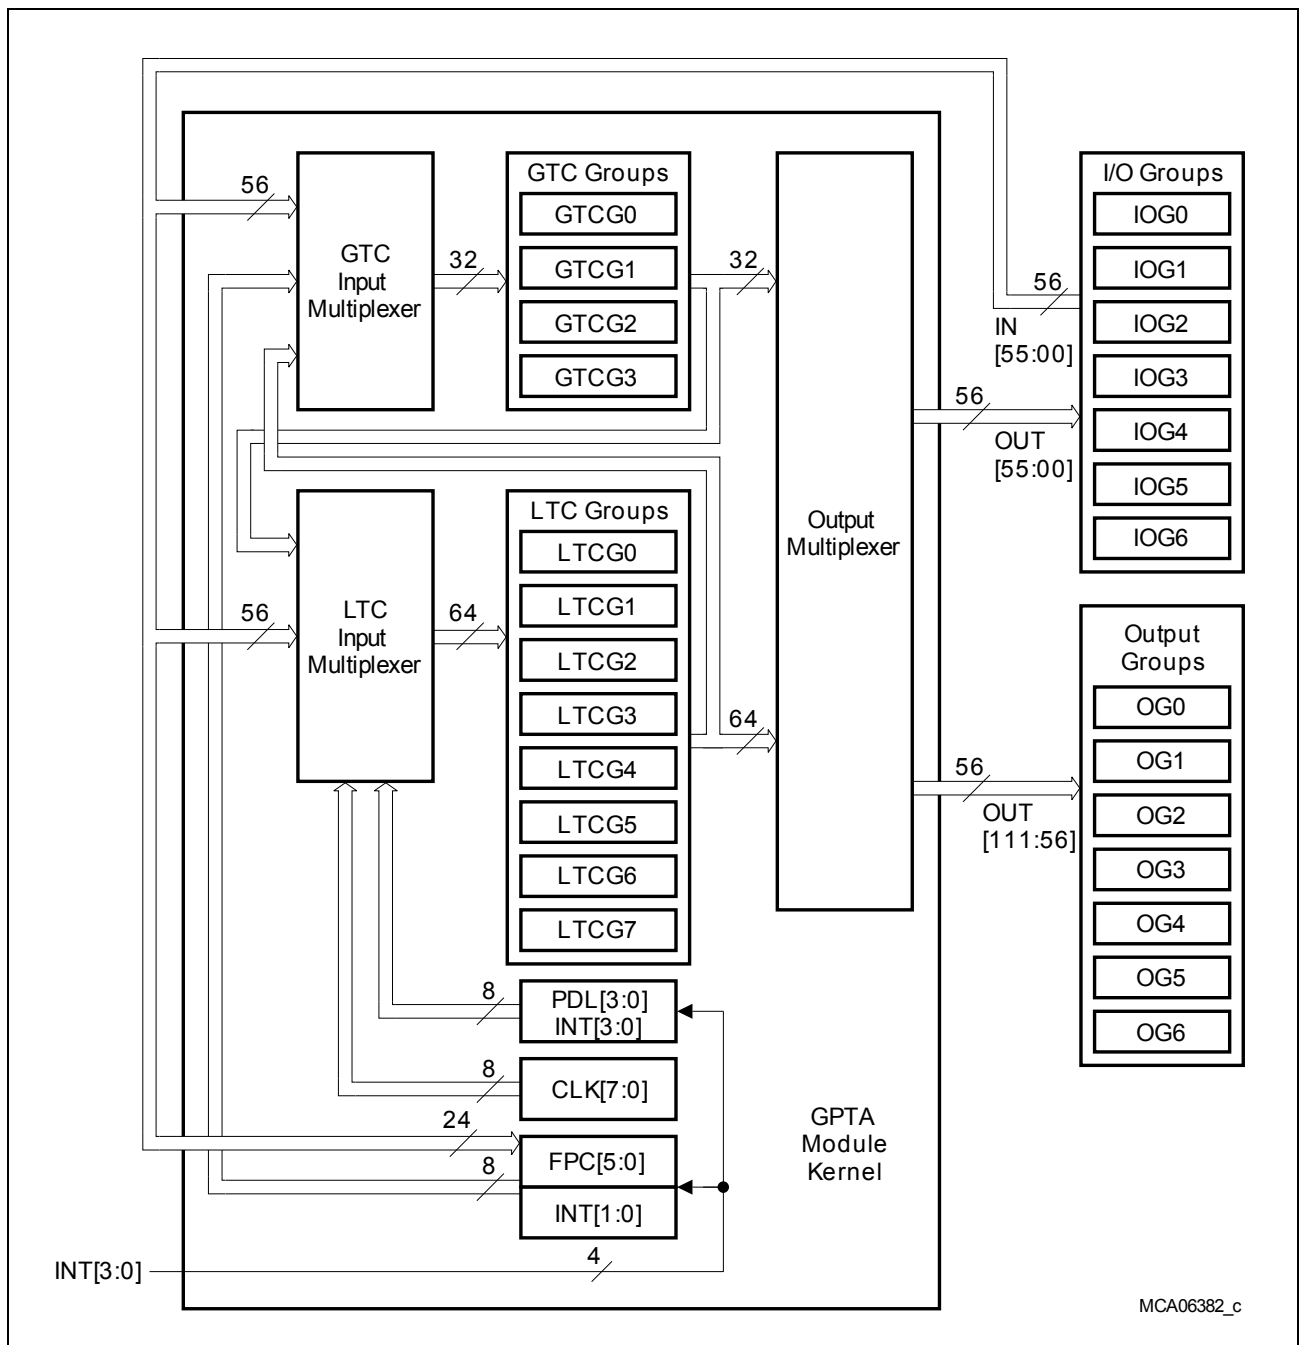
Figure 22-59 Input/Output Line Sharing Unit Overview

The last sentence of the first paragraph should be replaced by “The GPTA module provides a total of 56 input lines and 112 output lines, assigned to **seven** I/O groups IOG[6:0] and **seven** output groups OG[6:0].”

The first paragraph of Section 22.2.4.2 should be replaced by “The output multiplexer shown in Figure 22-59 and Figure 22-61 below connects the 32 GTC output lines and the 64 LTC output lines with the I/O groups (7 x 8 = 56 input/output lines) and the output groups (7 x 8 = 56 output lines).

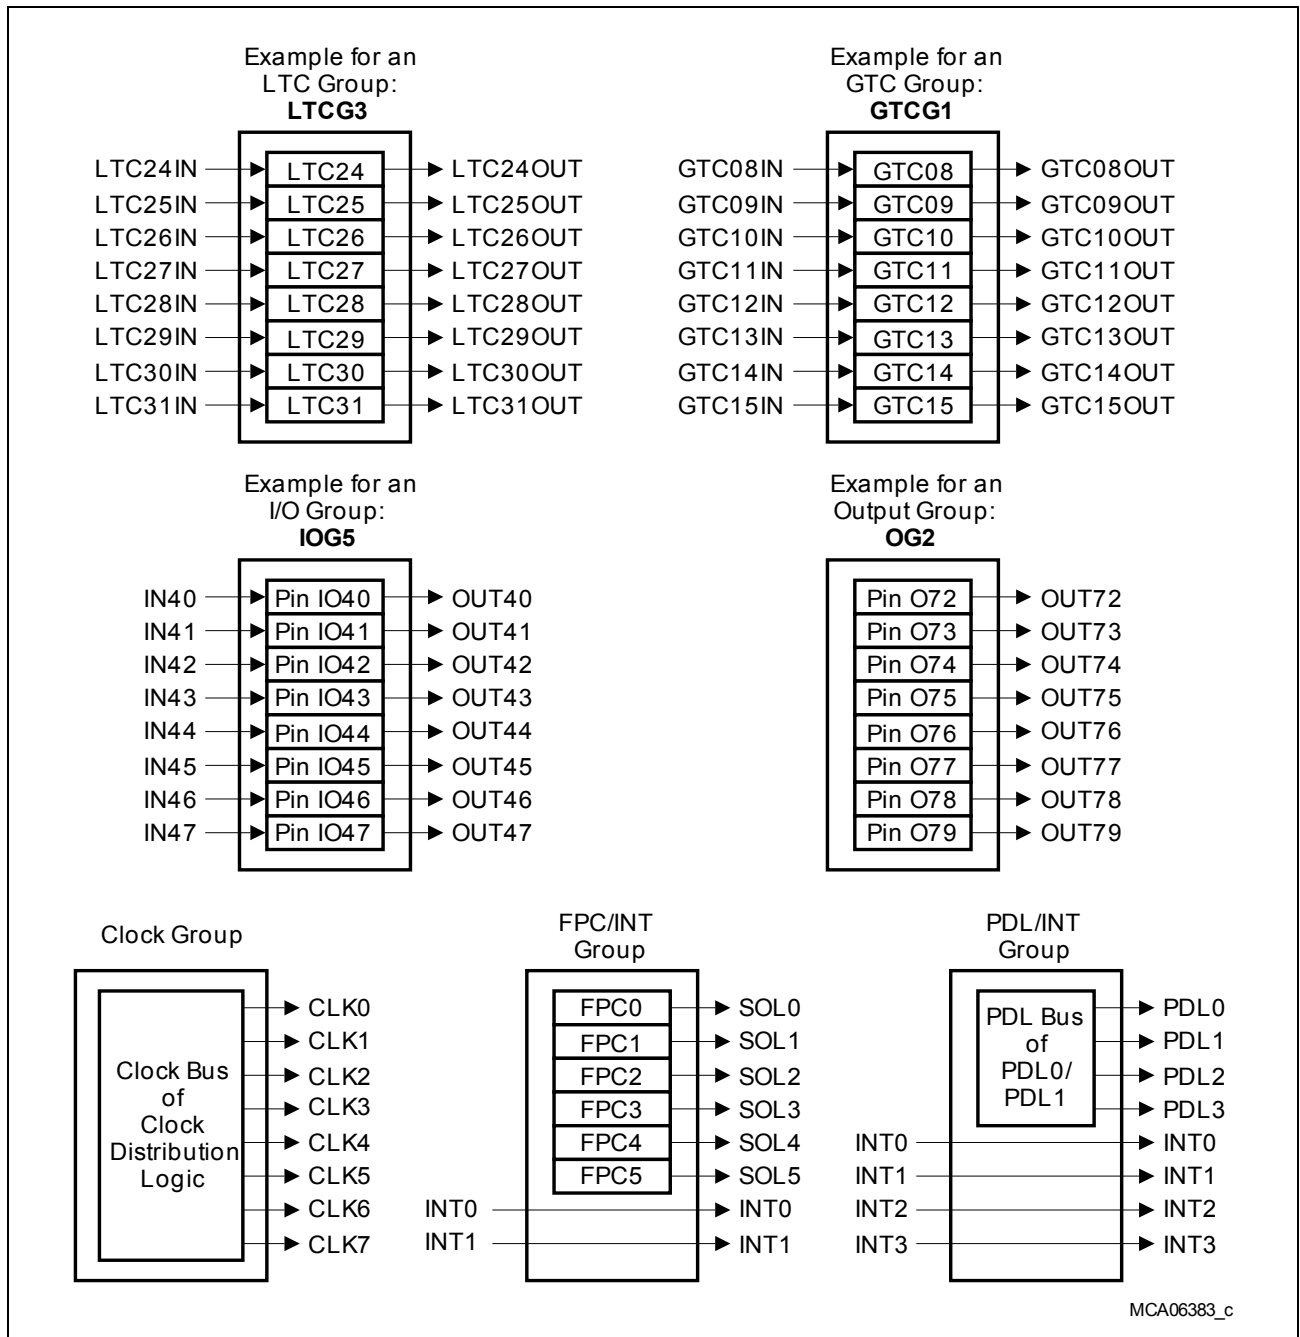
Figure 22-60 should be updated with the below figure with the example for OG2 corrected:

Figure 22-60 Group Definitions For I/O Line Sharing Unit
