TC1766

32-Bit Single-Chip Microcontroller

TC1766 Documentation Addendum

Revision History: **V1.2 2007-04**

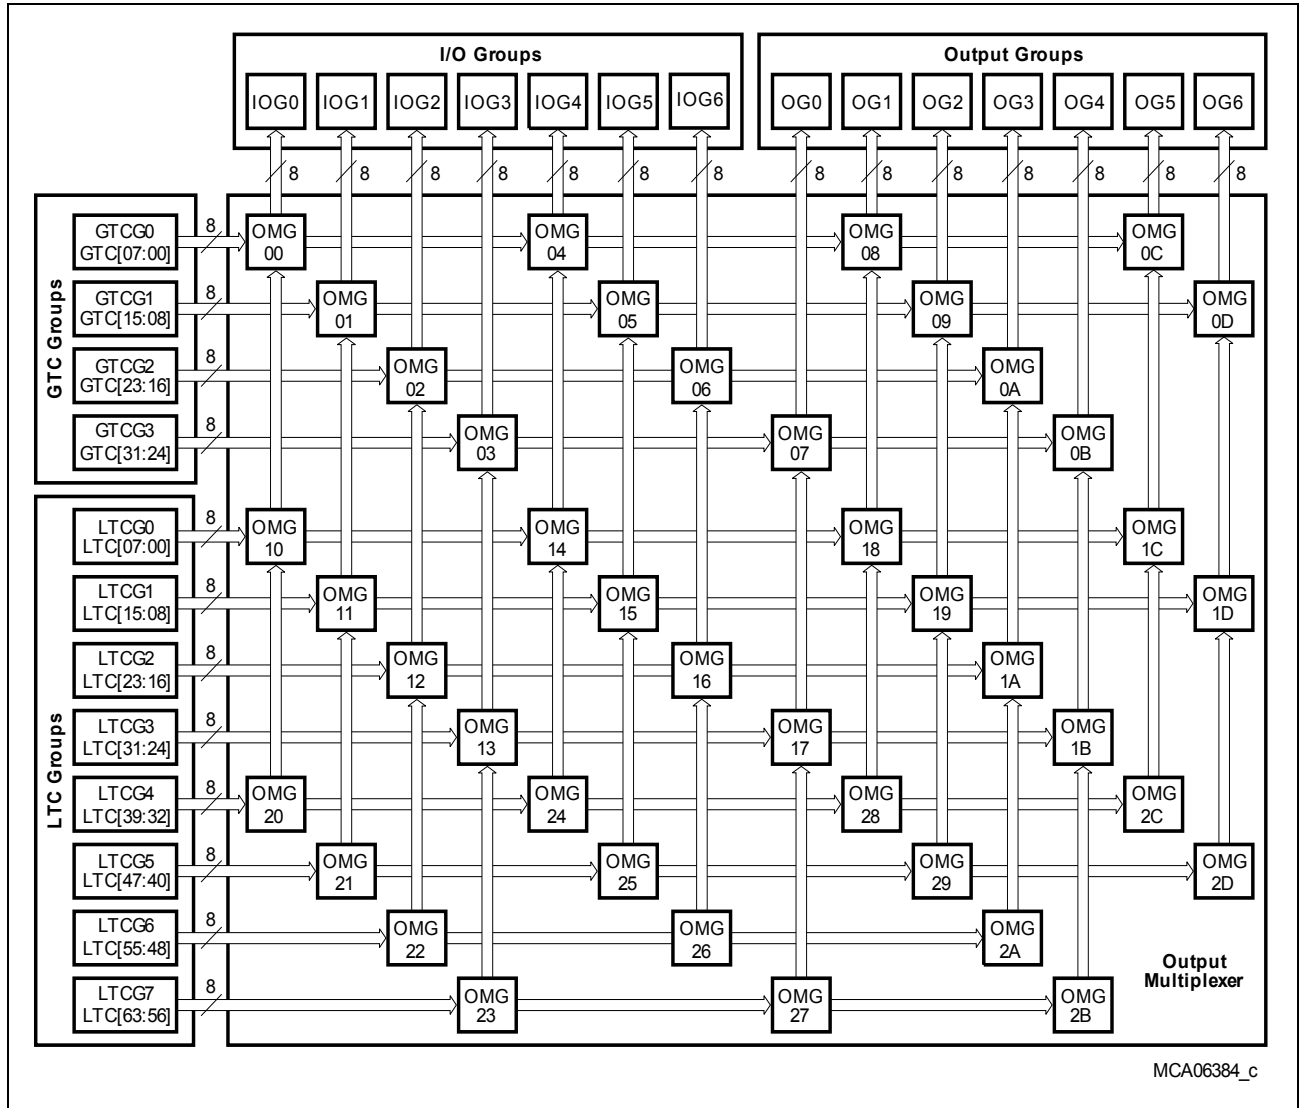
Figure 22-61 Output Multiplexer

The first paragraph of Section 22.2.4.2 should be replaced by “The output multiplexer shown in Figure 22-59 and Figure 22-61 below connects the 32 GTC output lines and the 64 LTC output lines with the I/O groups (7 x 8 = 56 input/output lines) and the output groups (7 x 8 = 56 output lines).

The third sentence onwards for the paragraph below Figure 22-61 should be replaced by “In the same way, I/O groups and output groups are grouped into 14 groups (**seven** I/O groups and **seven** output groups) with 8 lines each. IOG0 and OG0 share the same physical pins, similarly for IOG1 and OG1, IOG2 and OG2. IOG3 and IOG6 share the same physical pins for inputs and outputs.

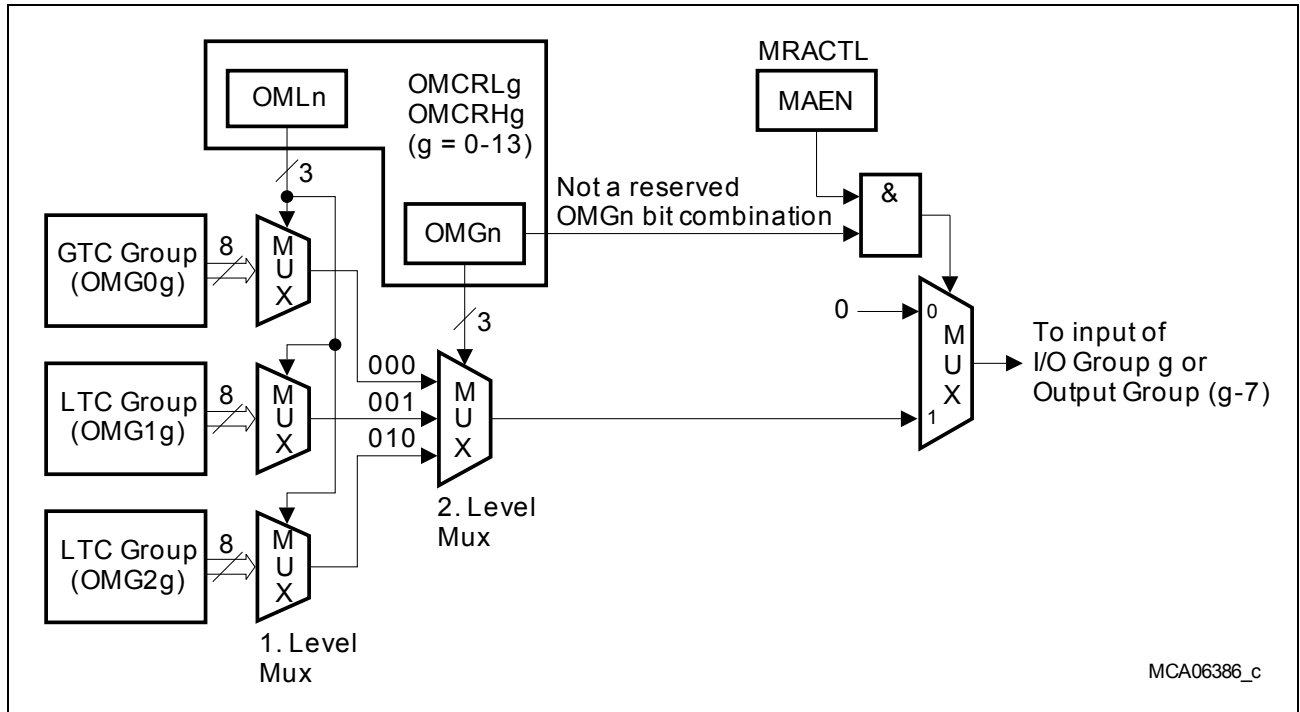
Figure 22-63 Output Multiplexer Group (Programmer's View)

“I/O groups **IOG0 to IOG6** are assigned to index variable ($g = 0$ to **6**) and output groups **OG0 to OG6** are assigned to index variable ($g = 7$ to 13).”

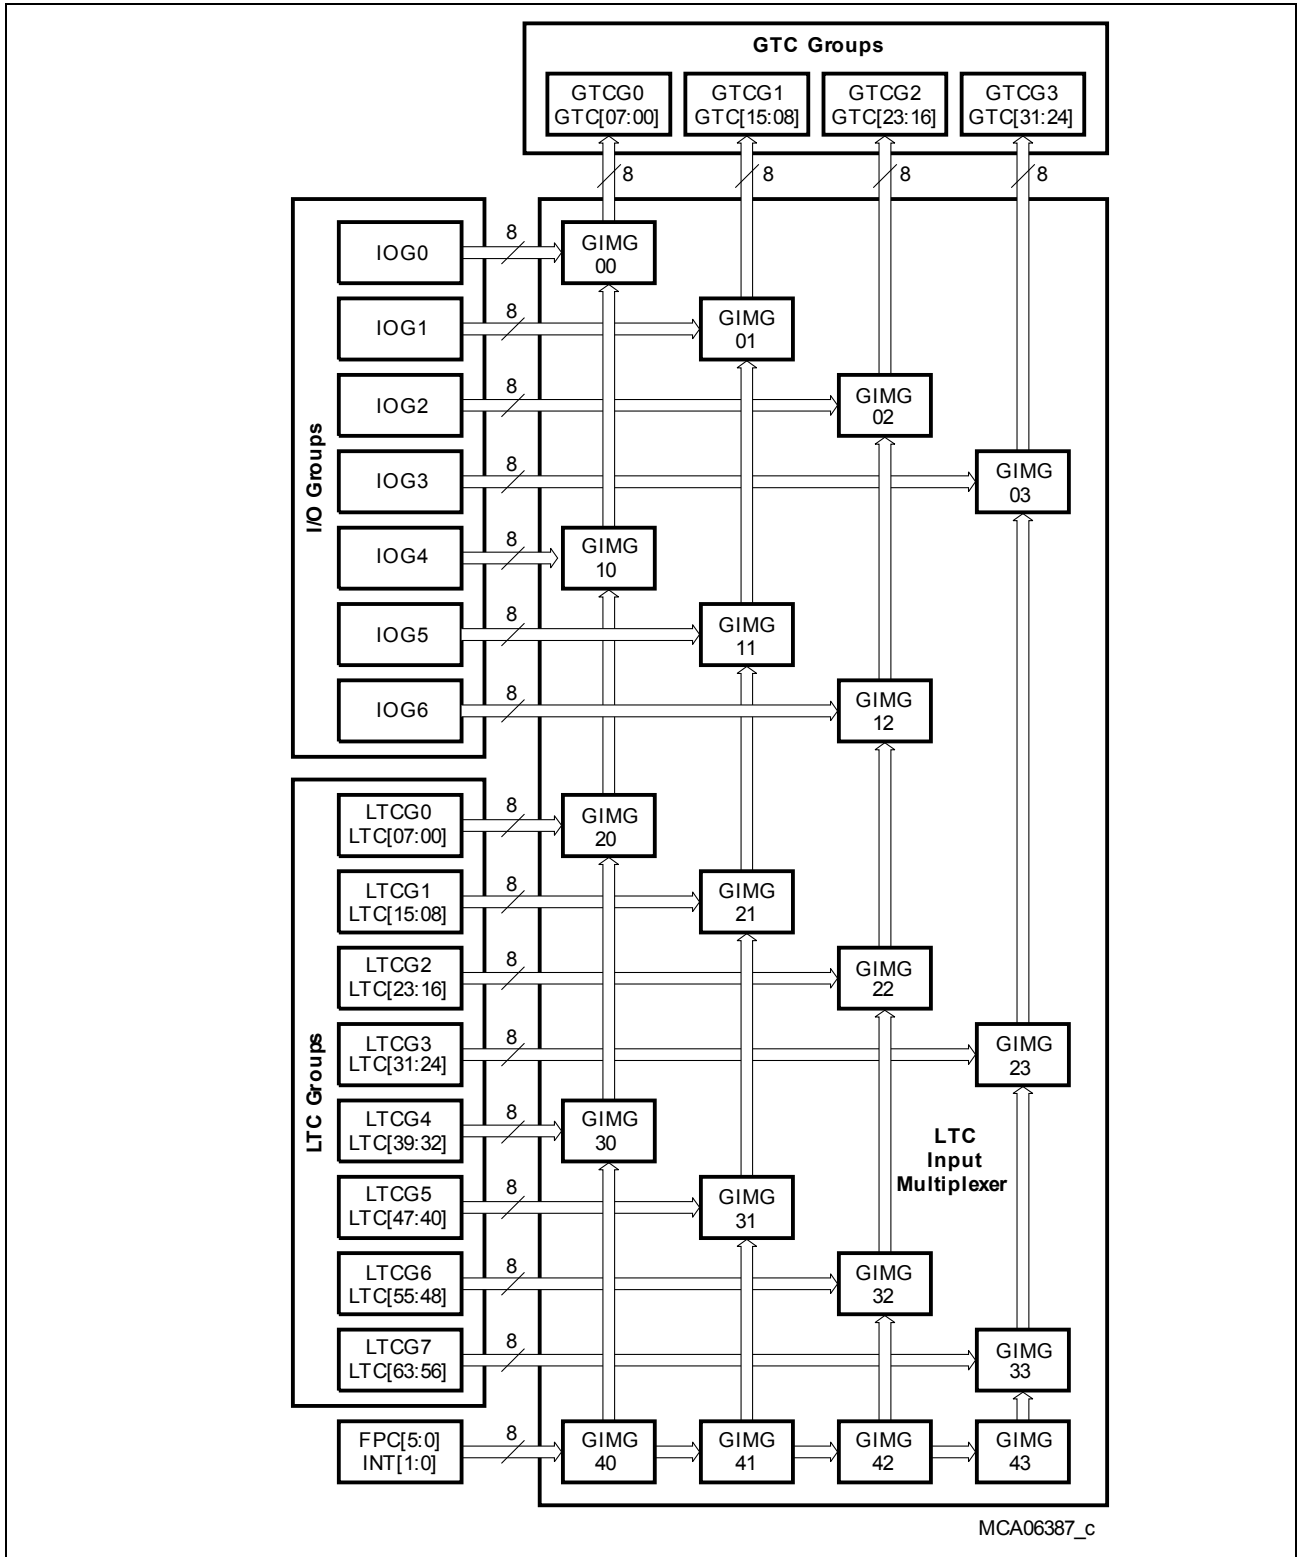
Figure 22-64 GTC Input Multiplexer

“For example, based on Figure 22-64, each of the eight GTC input multiplexer output lines to GTC group GTCG2 is connected via five **GIMGn2** (n =0-4) with the eight outputs of two I/O group (IOG2 and IOG**6**), two LTC groups (LTCG2 and LTCG6), and the FPC/INT group.”

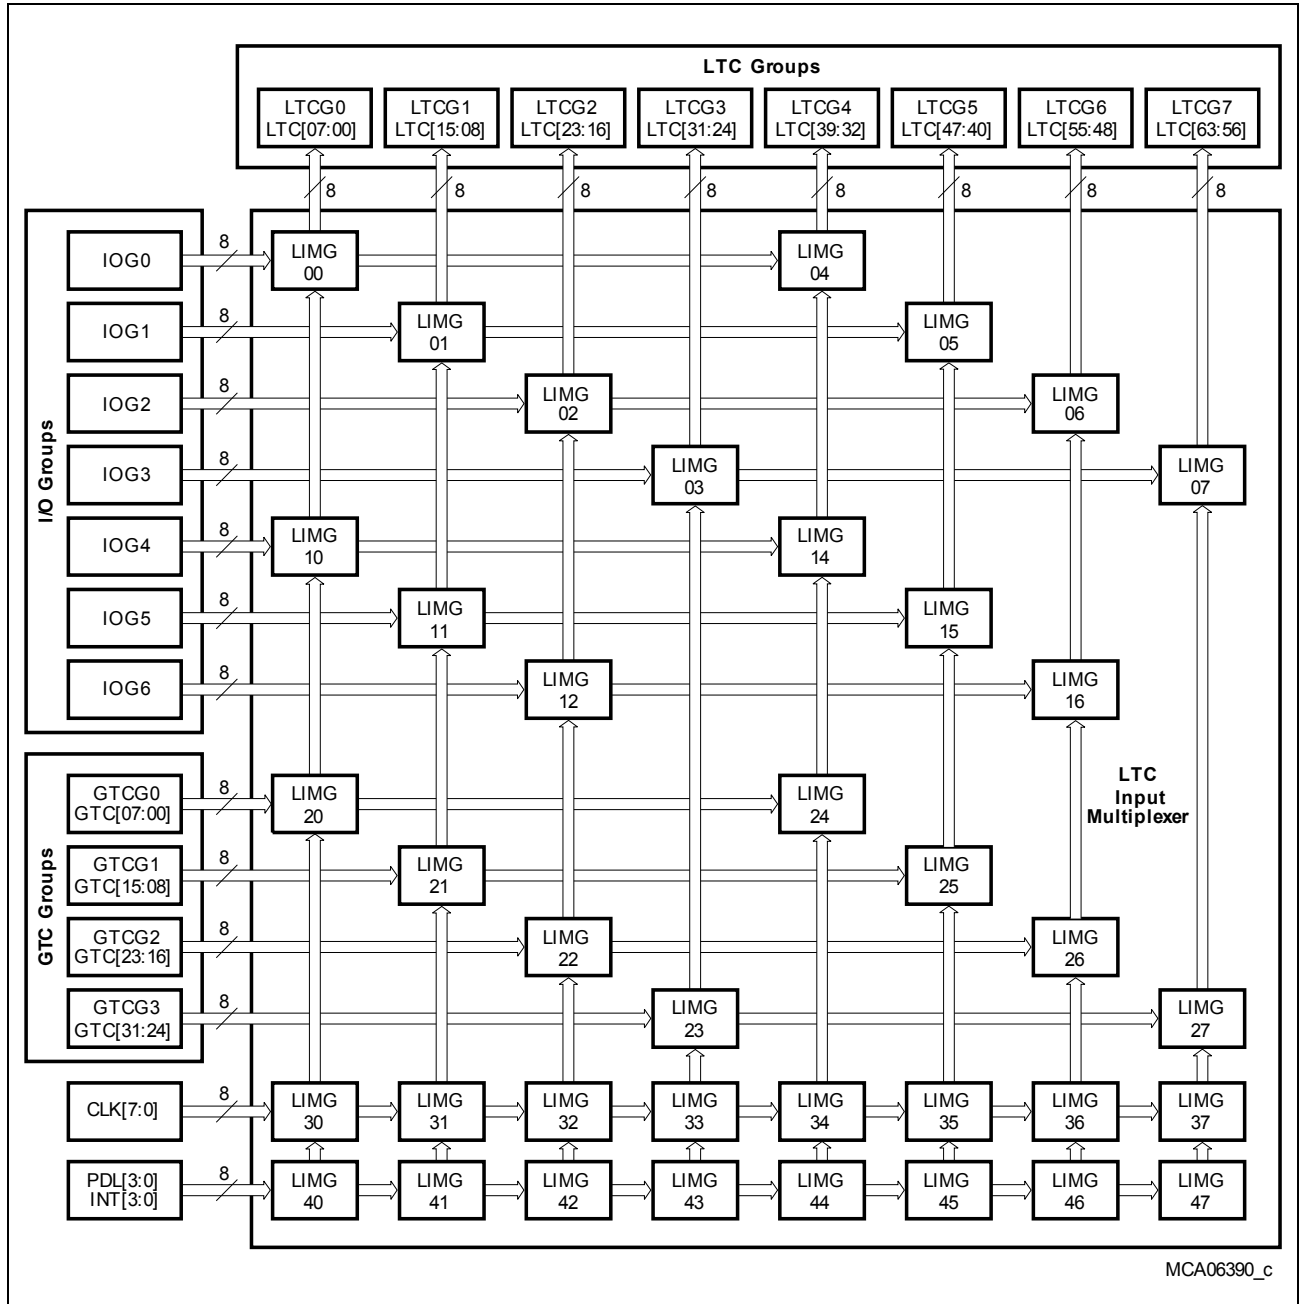
Figure 22-67 LTC Input Multiplexer

“For example, based on Figure 22-67, each of the eight LTC input multiplexer output lines to LTC group LTG2 is connected via five LIMGn2 (n = 0-4) with the eight outputs of two I/O group (IOG2 and IOG6), one GTC group (GTCG2), the clock group, and the PDL/INT group.”

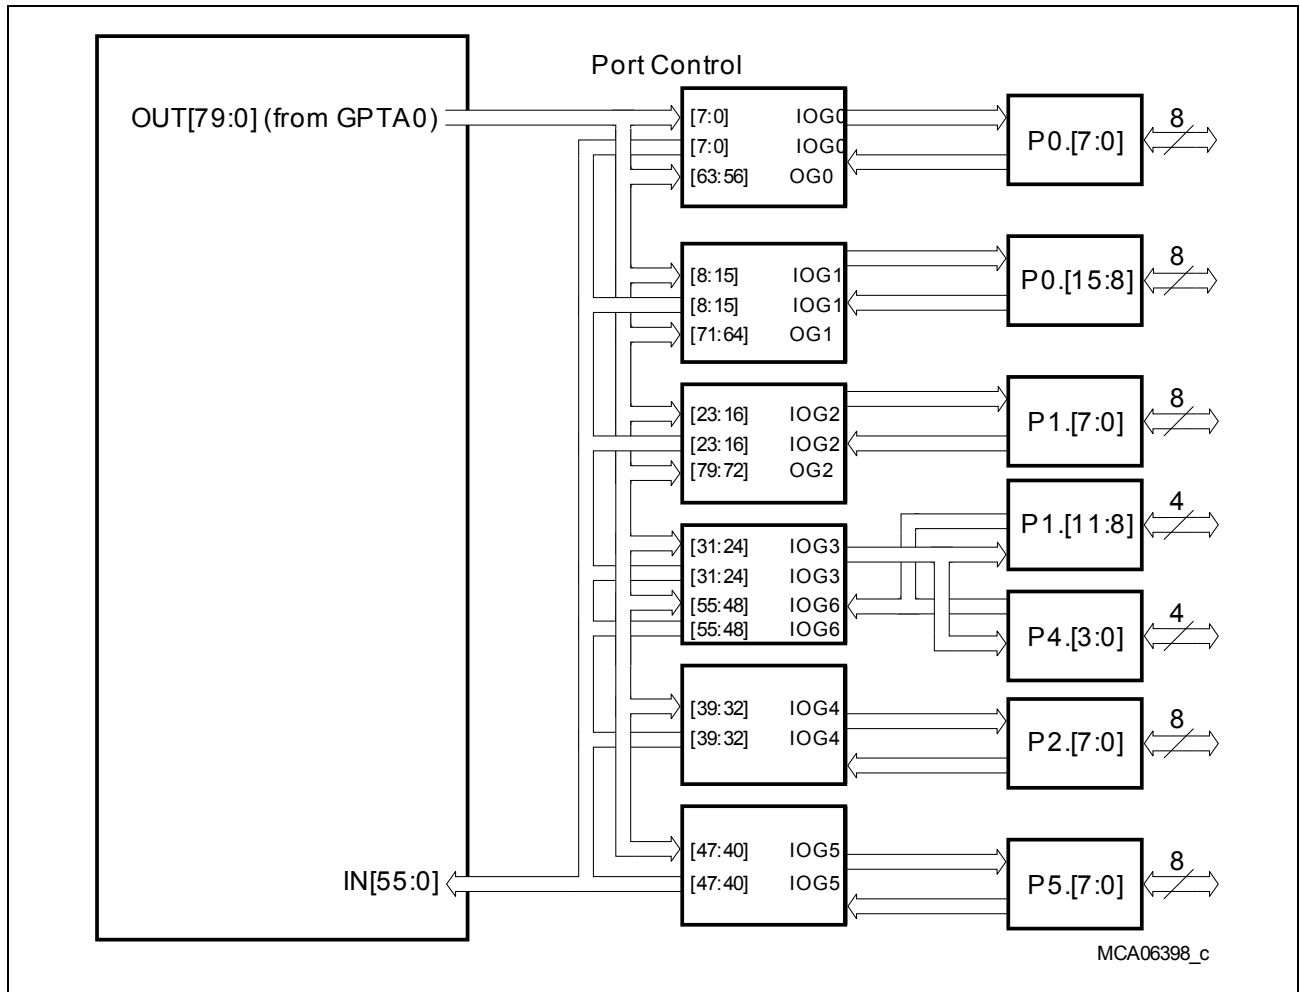
Figure 22-75 I/O Port Line Assignment

“In the TC1766, the **seven** I/O groups and **three** output groups of GPTA0 with their input lines IN[55:0] and output lines OUT[79:0] are assigned to five 8-bit port groups and two 4-bit port groups as shown in Figure 22-75.”
