Device **XC161CJ-16F**
Marking/Step **(E)ES-BB, BB**
Package **PG-TQFP-144-7, P-TQFP-144-19**

This Errata Sheet describes the deviations from the current user documentation.

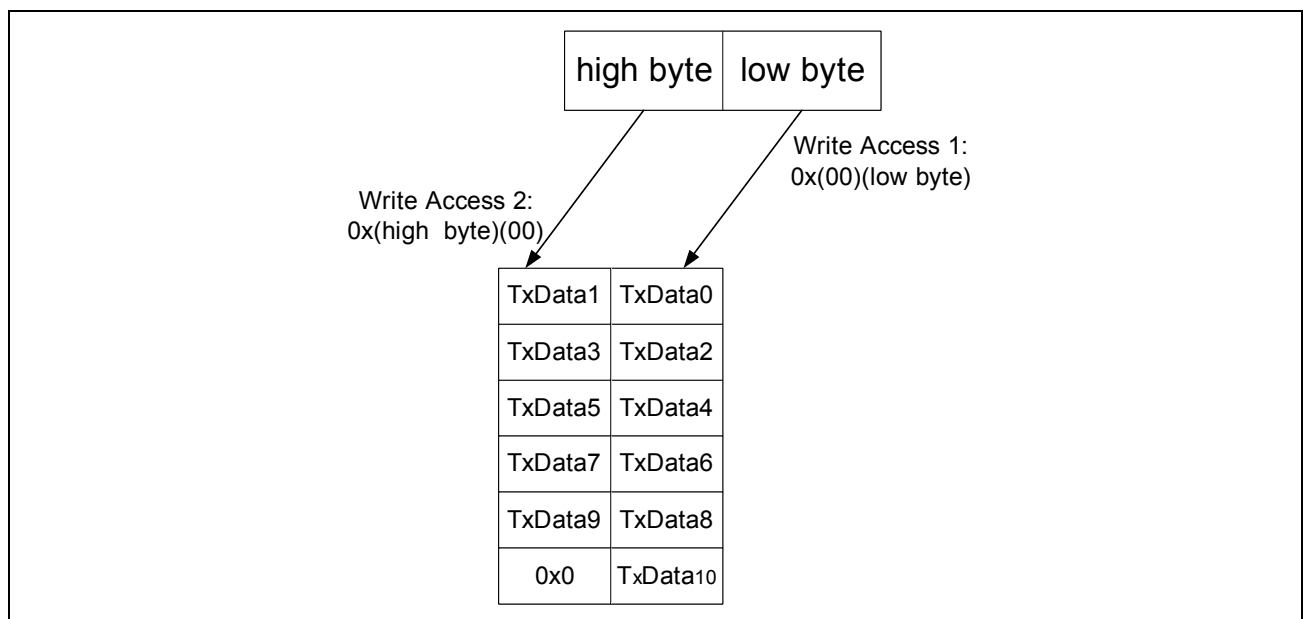
Note: Odd byte is written to odd position, even byte to even position.

Every piece of information has to be stored in Register TxD0.

Figure 2 Scheme of writing to TxD0
